Demolition of a Historic Resource Application

Subject Property: 4535 Lake Harriet Parkway East

As requested, we completed a structural condition review including a site observation on September 12, 2013 in order to provide opinions and recommendations based on our available information in regards to the structural remediation required at the 4535 Lake Harriet Parkway single family residence.

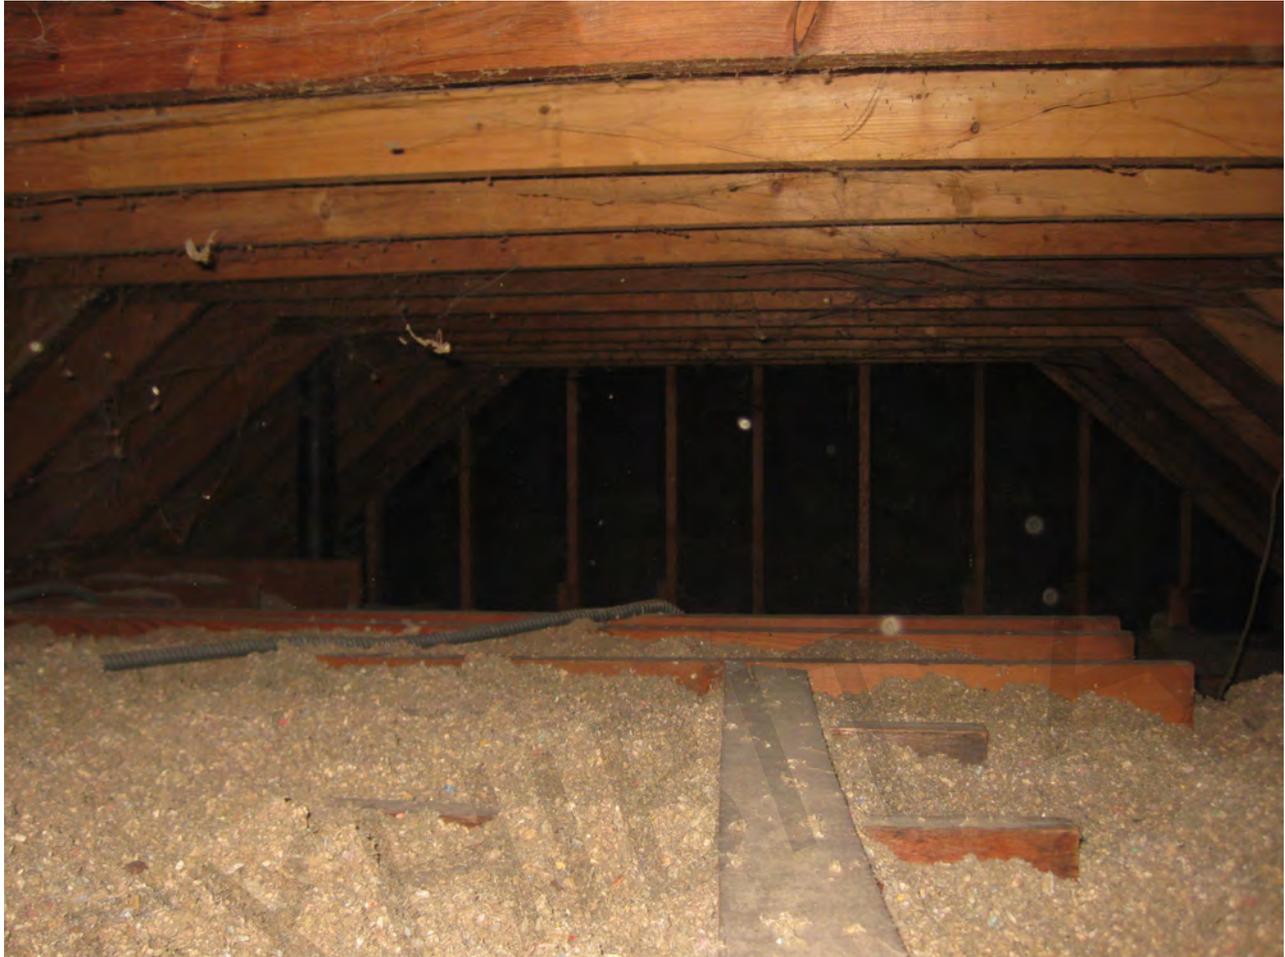
Photograph 2, Hand Framed Roof Trusses

The existing roof structure is typically hand framed propped trusses constructed from 2x6 dimensional lumber, as shown in Photograph 2.

Based on the requirements of the 2007 Minnesota State Building Code and calculations performed, the roof structure is judged an unsafe structure, and must be repaired or replaced.

Due to the style of framing, I recommend that the roof structure is removed and replaced with a new prefabricated wood roof truss structure bearing on the existing walls.

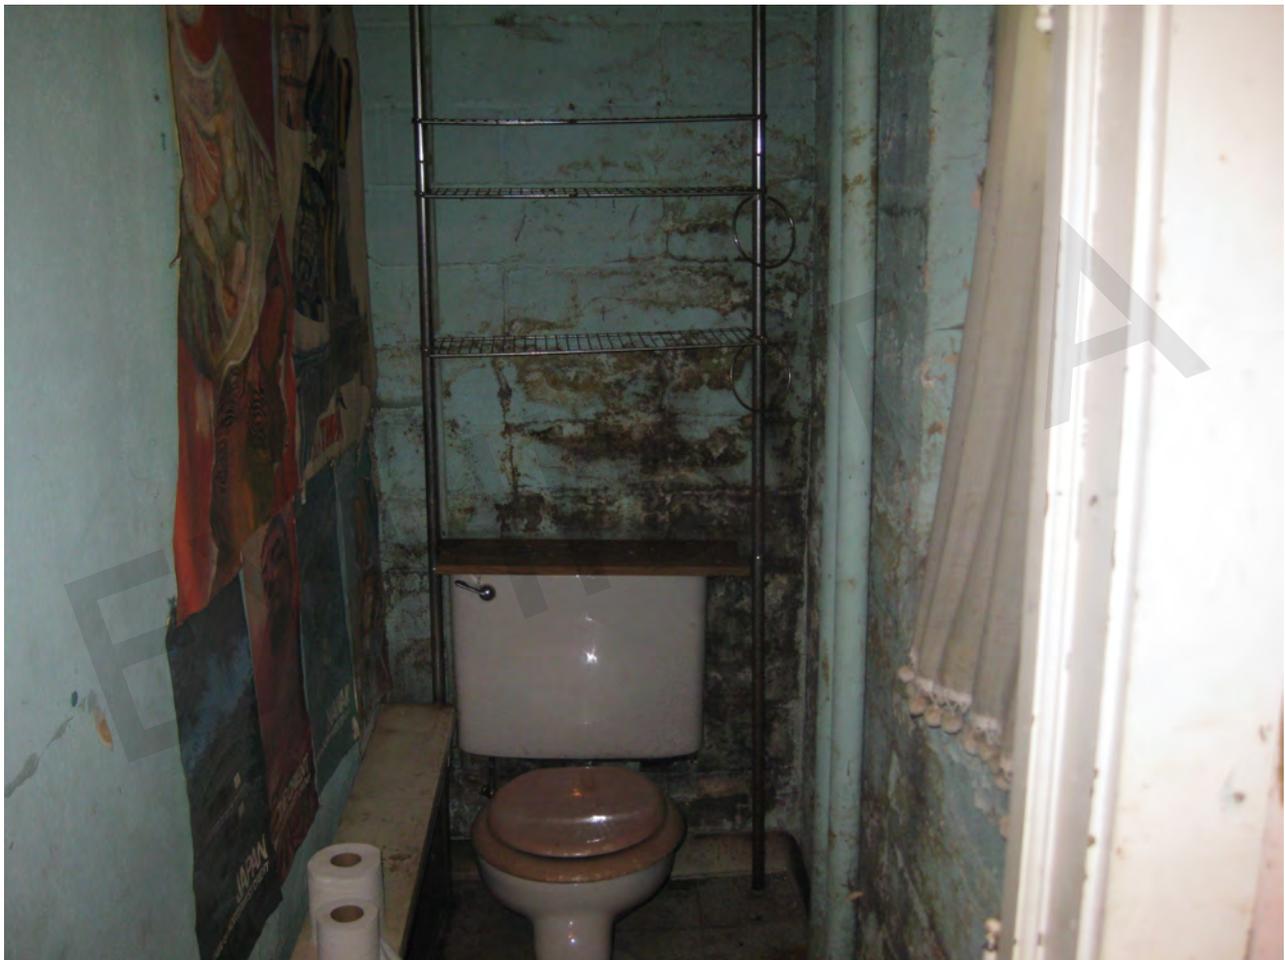
The basement exhibits signs of water damage and infiltration throughout. Refer to Photographs 3 and 4.

Photograph 3, Water Staining at Basement Foundation Wall

I recommend that drain tile be installed at the wall exterior below the basement slab on grade location, the exterior of the masonry wall repointed and waterproofed, and the site regraded to keep water away from the structure.

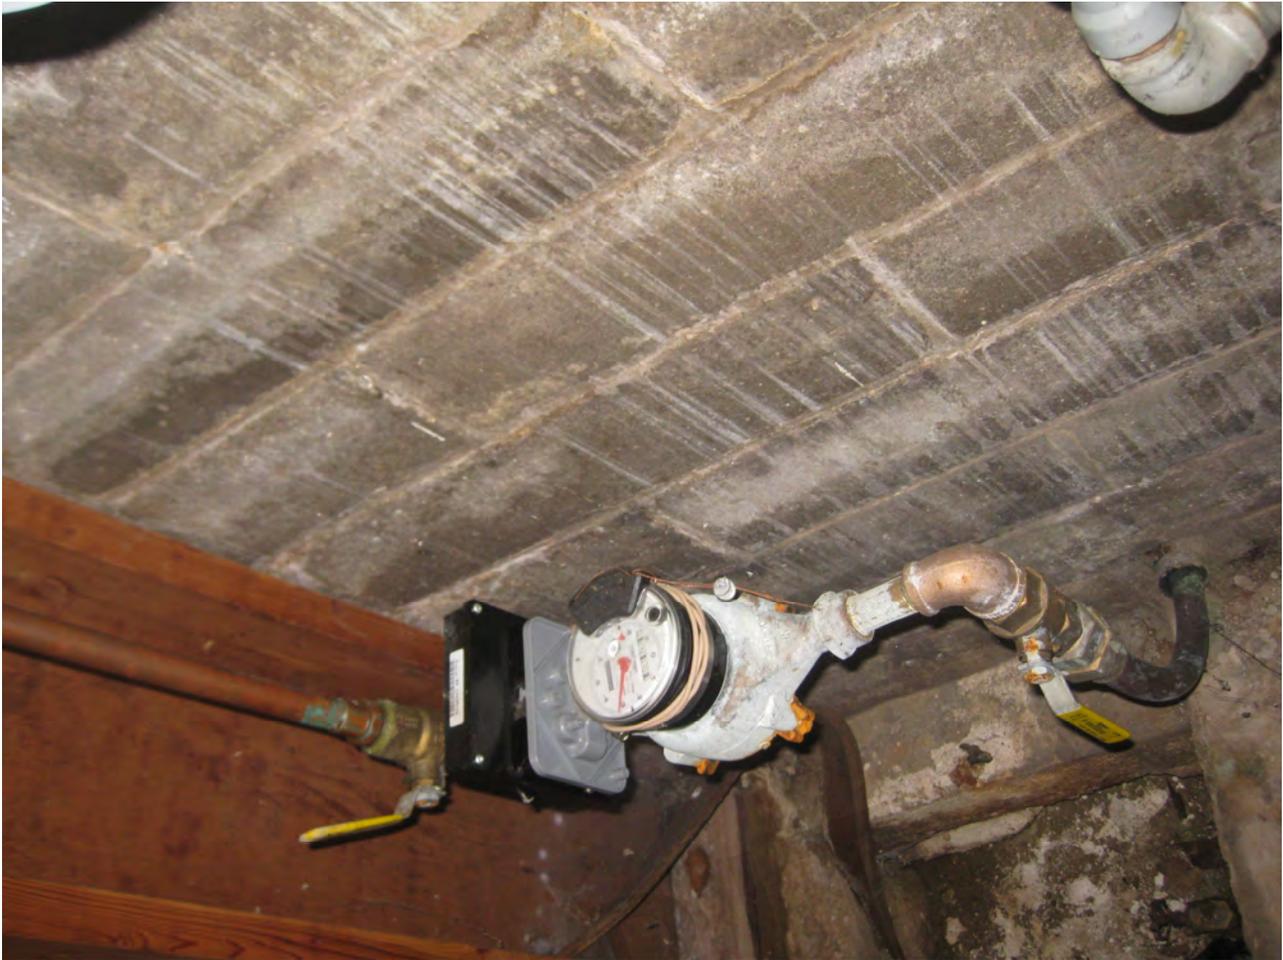
Photograph 4, Water Staining at Basement Foundation Wall

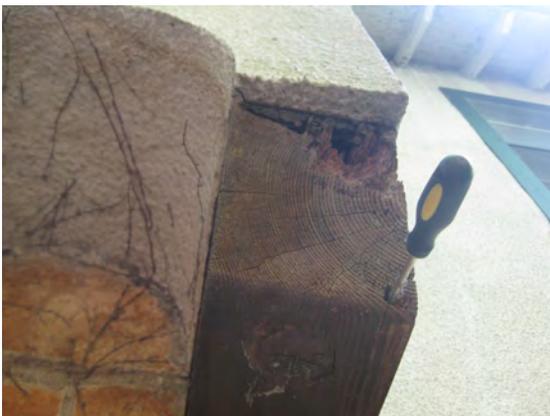
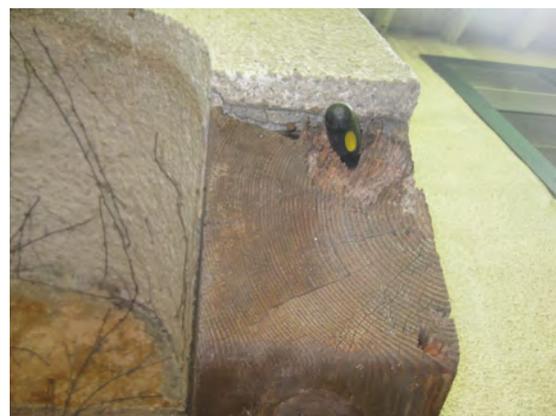
The exterior walls and windows exhibit signs of rot and cracking throughout, refer to Photographs 5 through 10.

Photographs 5, Screwdriver in Rotted Exterior Support Beam

I recommend that the exterior stucco and siding is removed to expose areas of wood rot in the framing below, the structural rot is remediated through replacement and repair, and the stucco and siding is replaced.

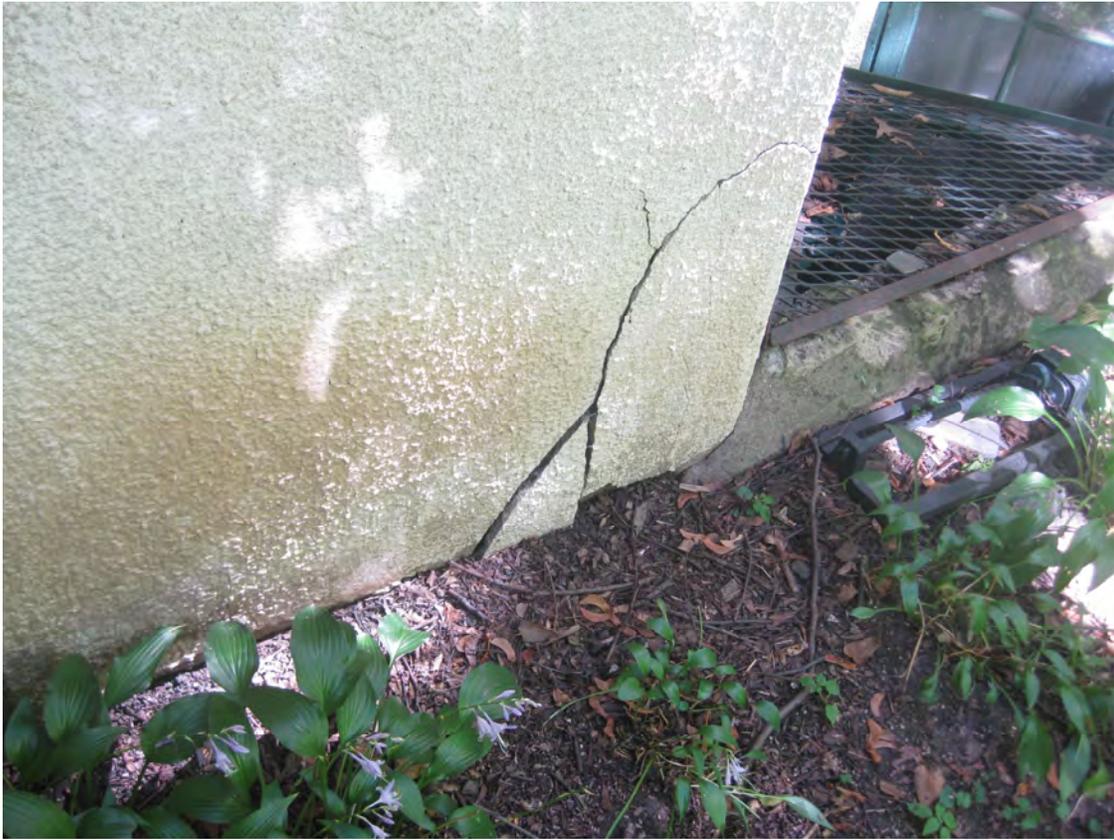
Photograph 6, Cracking and Separating Stucco

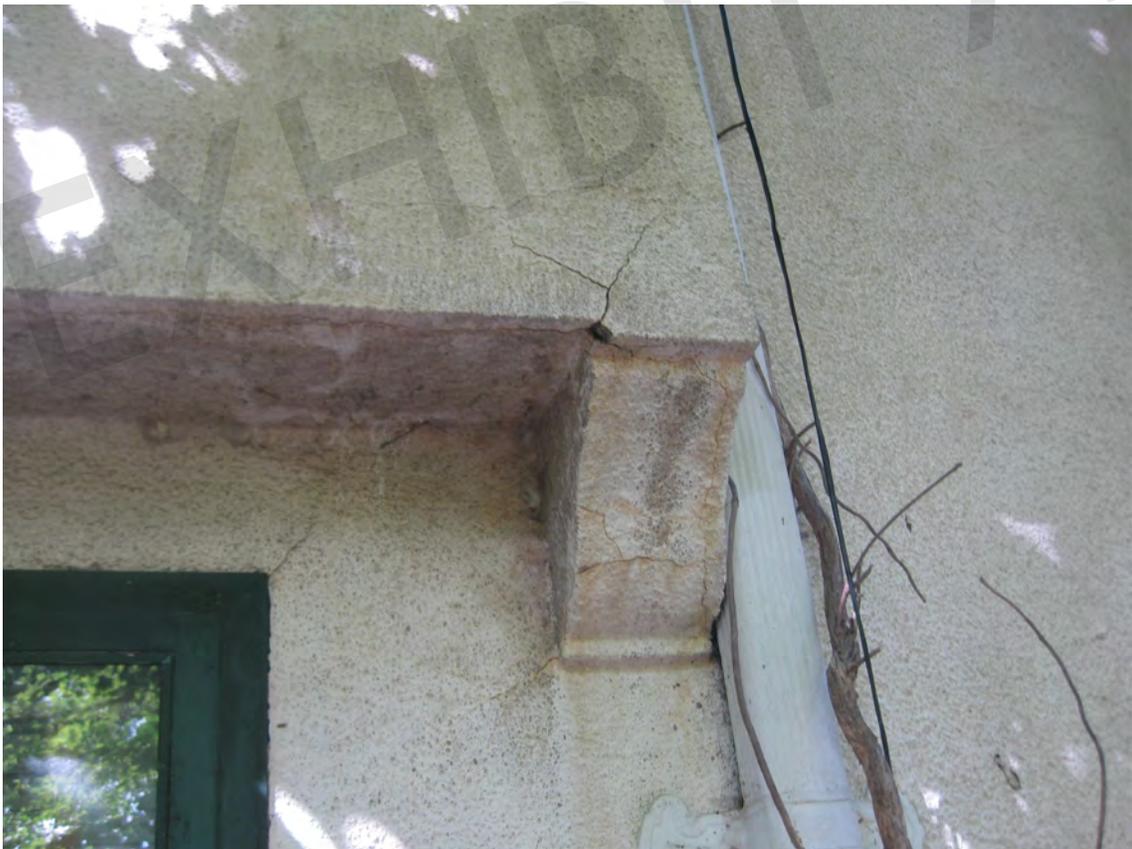
Photograph 7, Cracking Stucco with Signs of Water Behind Stucco

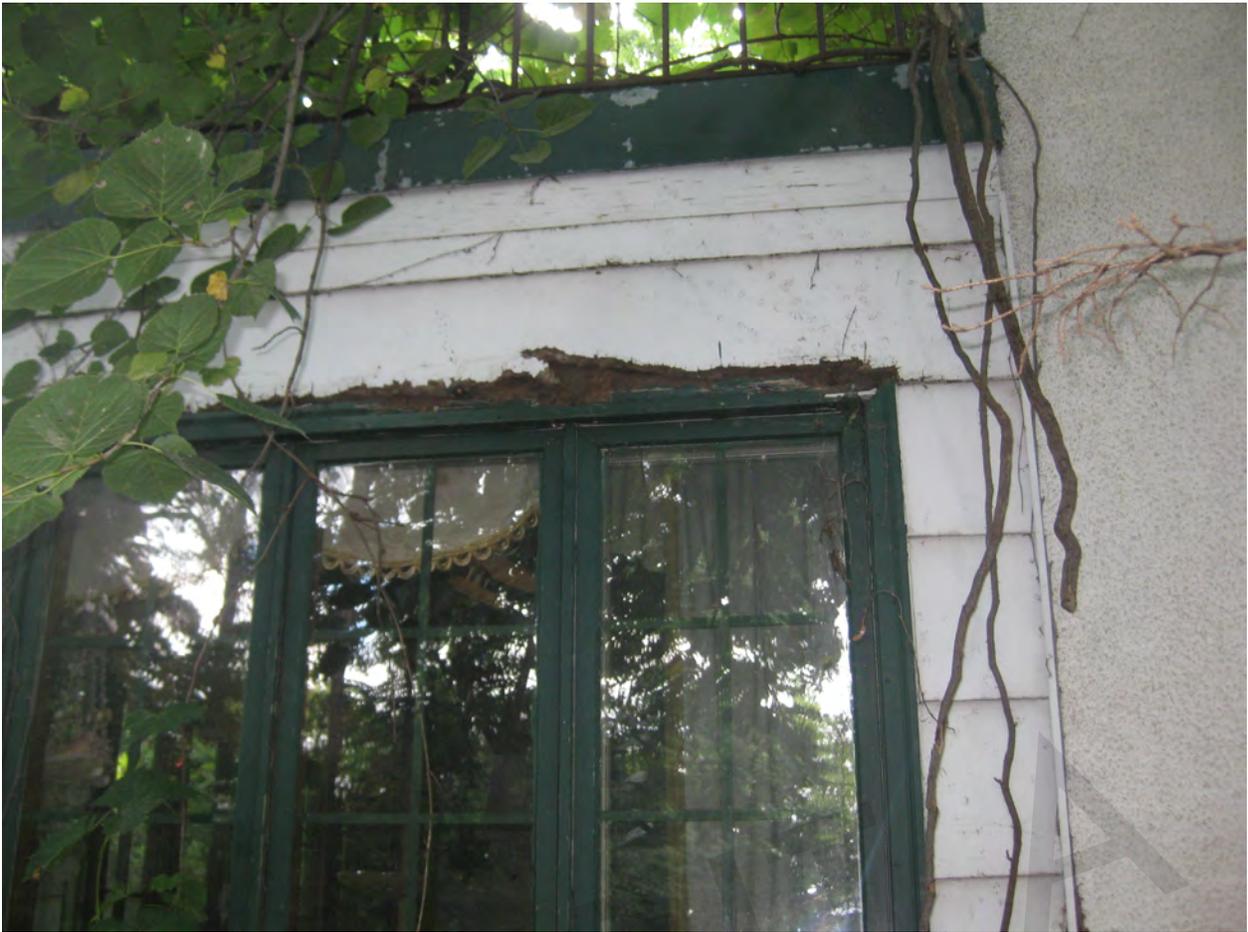
Photograph 8, Rotted Wood Lap Siding and Rotted Exterior Window

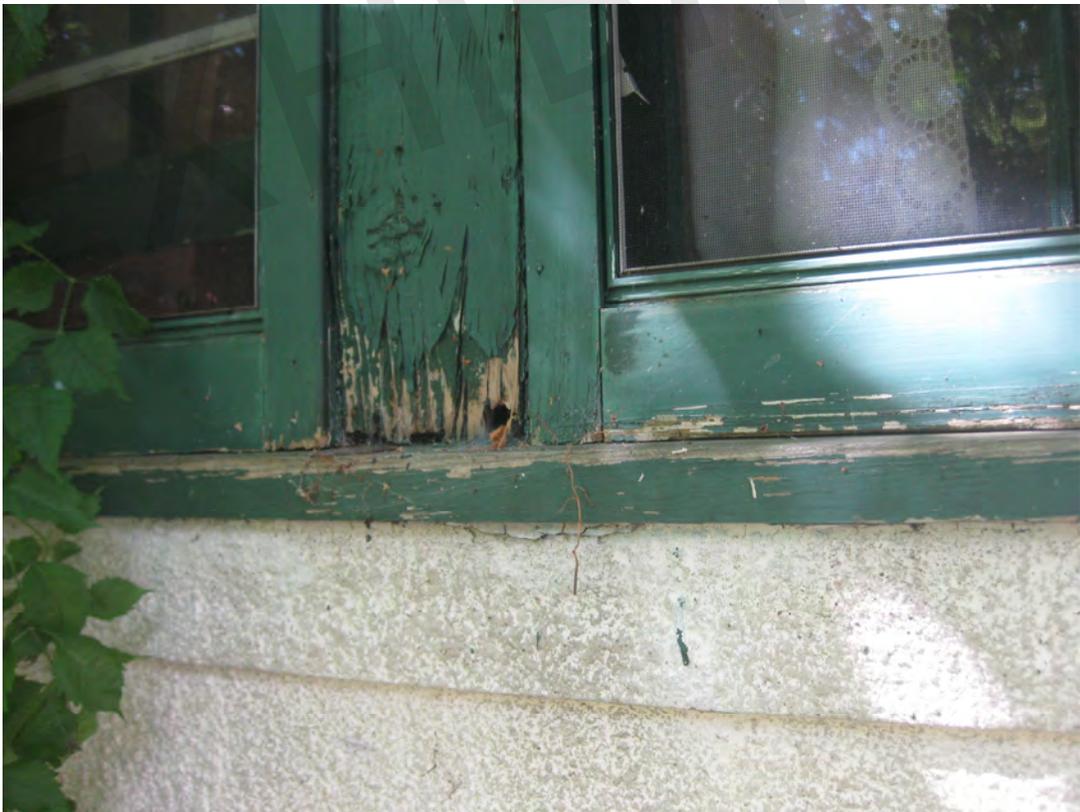
Photograph 9, Rotted Exterior Window

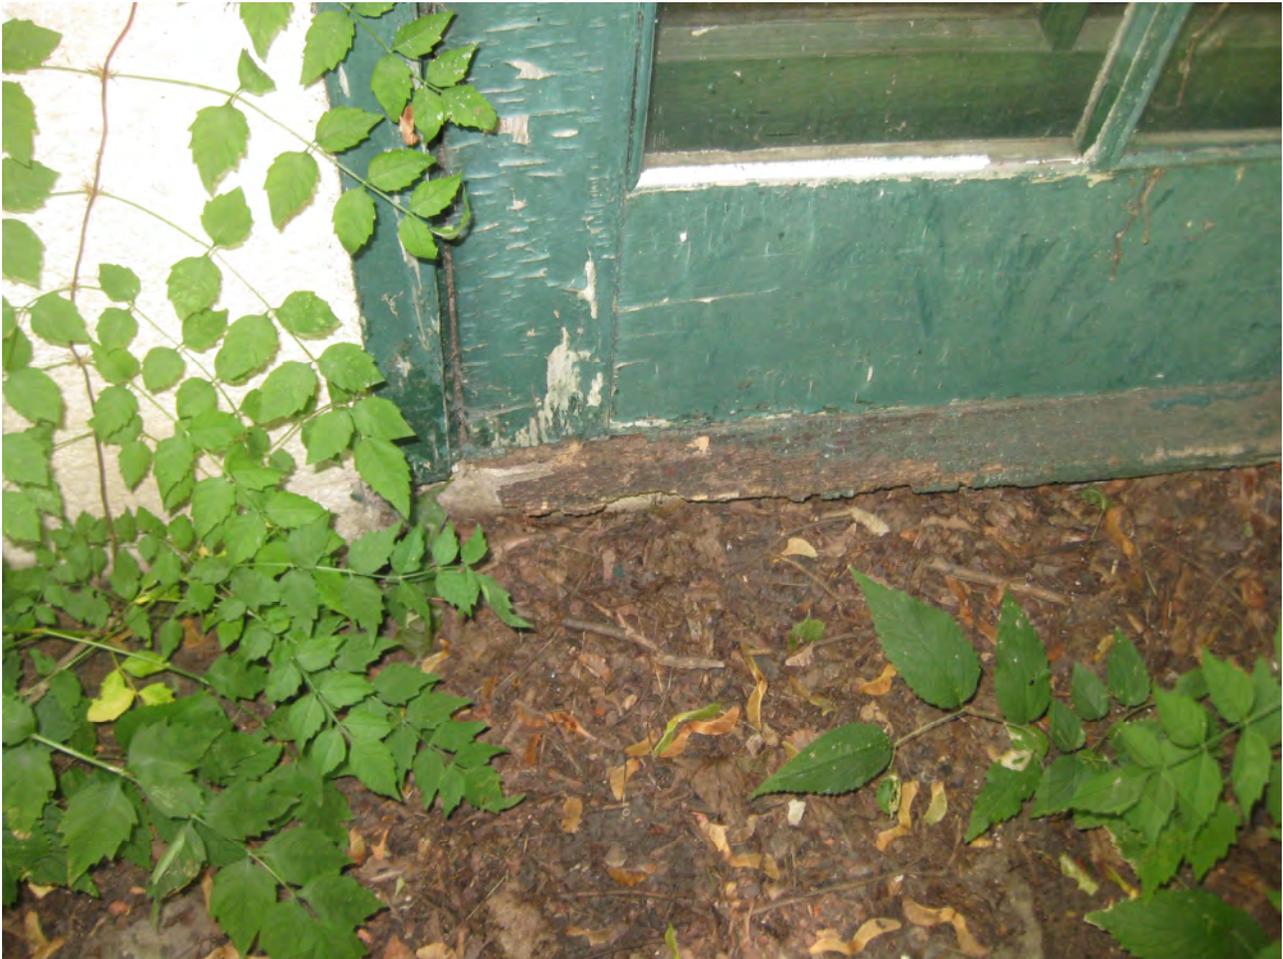
Photograph 10, Rotted Exterior Door

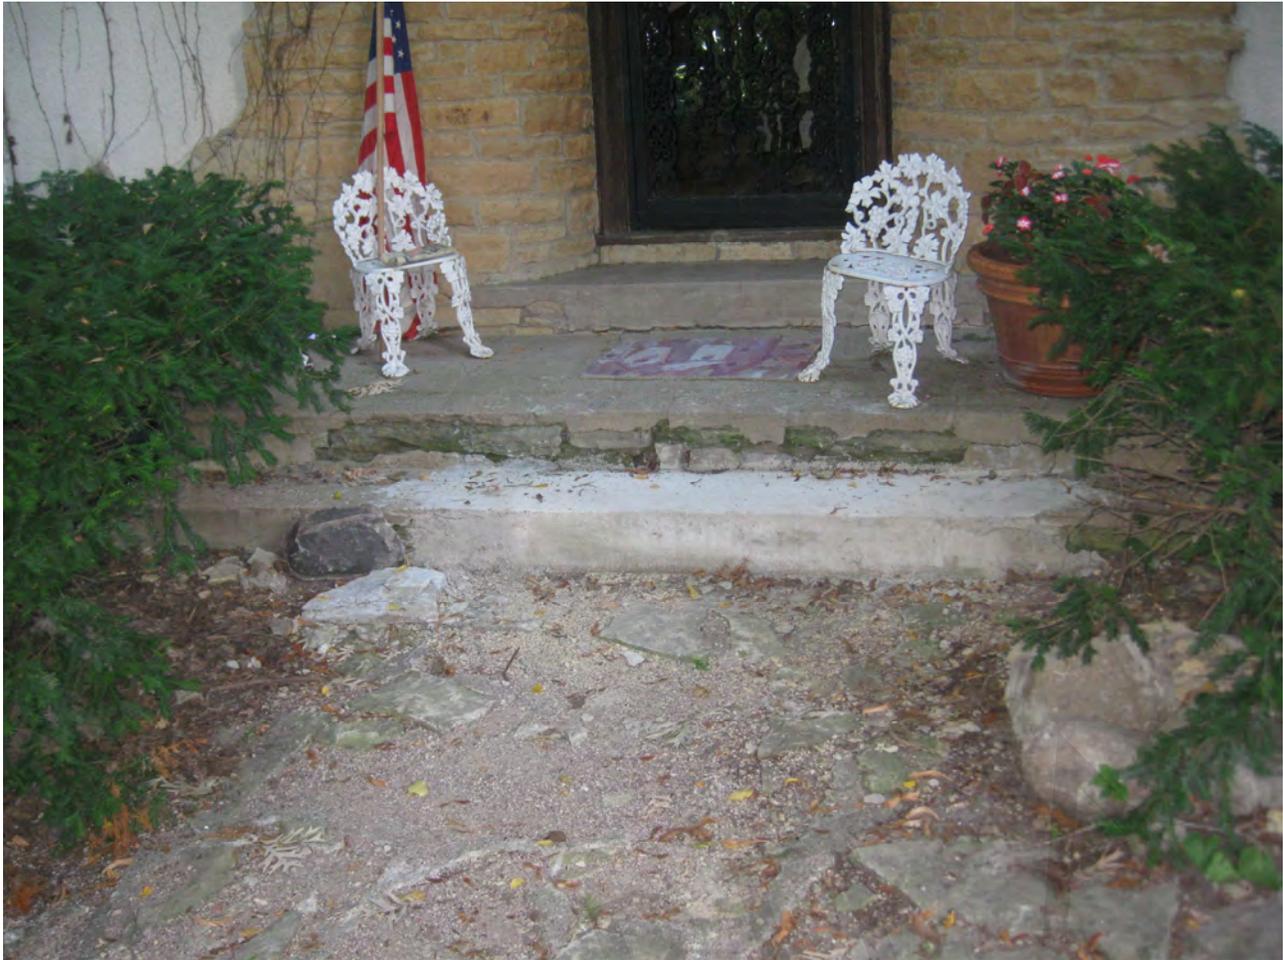
Building sitework, such as stairs and sidewalks are in very poor condition. Refer to Photograph 11.

Photograph 11, Cracked and Failing Front Stairs and Front Sidewalk

I recommend that the affected areas are removed and replaced with industry standard site work construction.

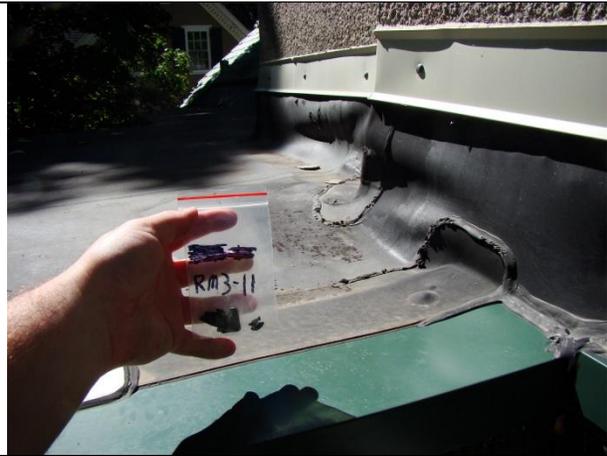
Rm3-11, Tar Layer Under Rubber Contains Asbestos

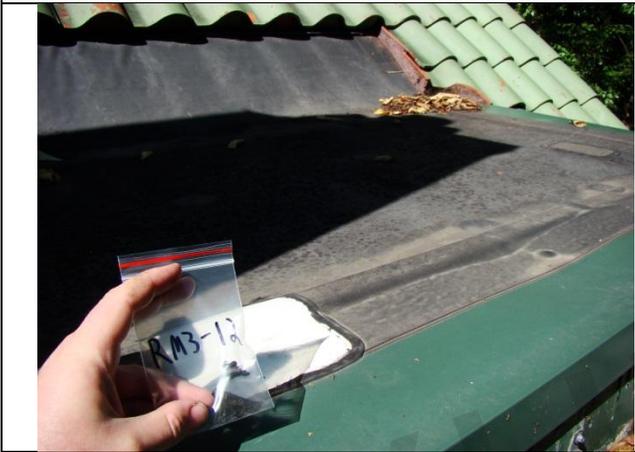
Rm3-12, Tar Layer Under Rubber Contains Asbestos

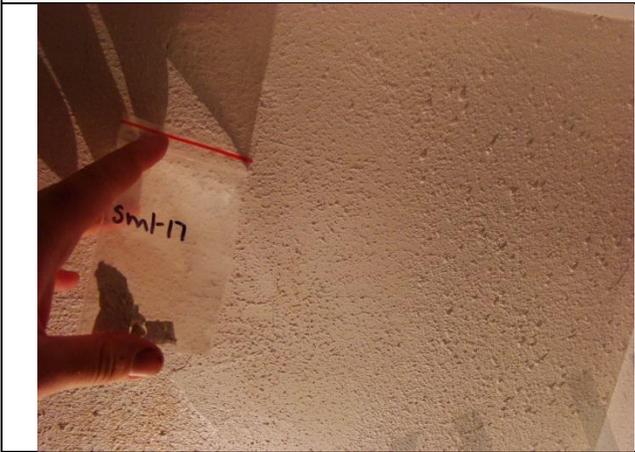
Sm1-17, Contains Asbestos

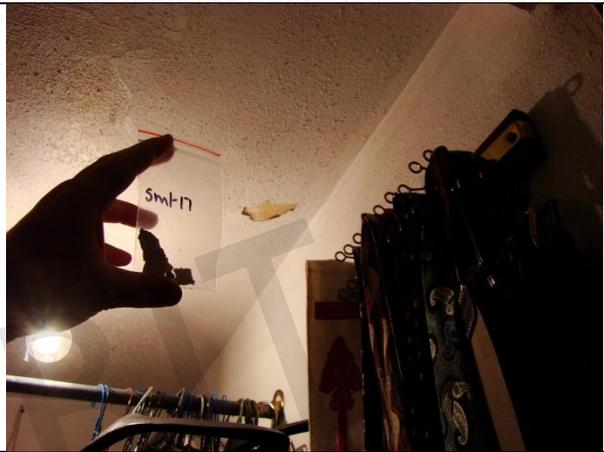
Sm1-17, Contains Asbestos

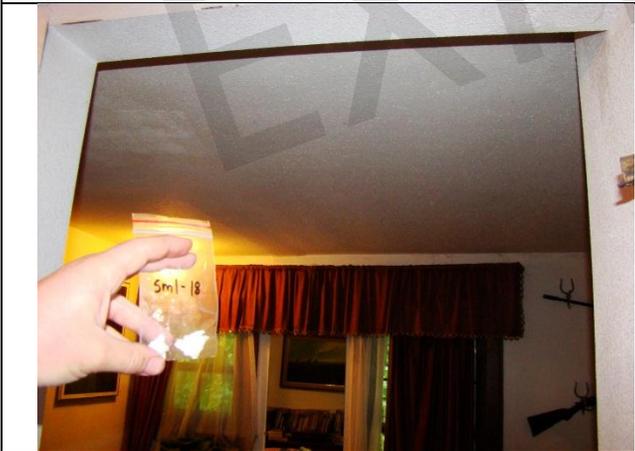
Sm1-18, Contains Asbestos

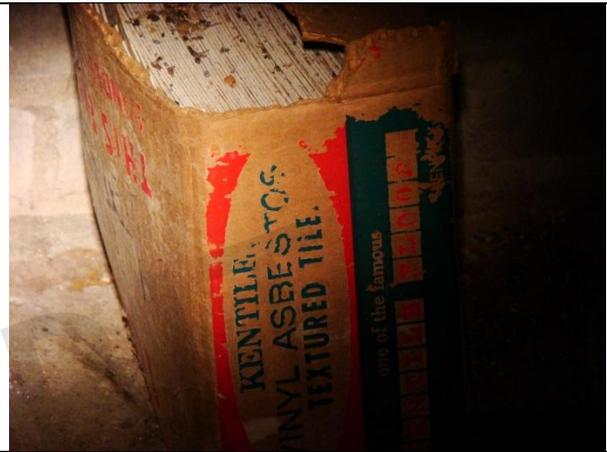
Box of asbestos floor tile found in basement under stairs

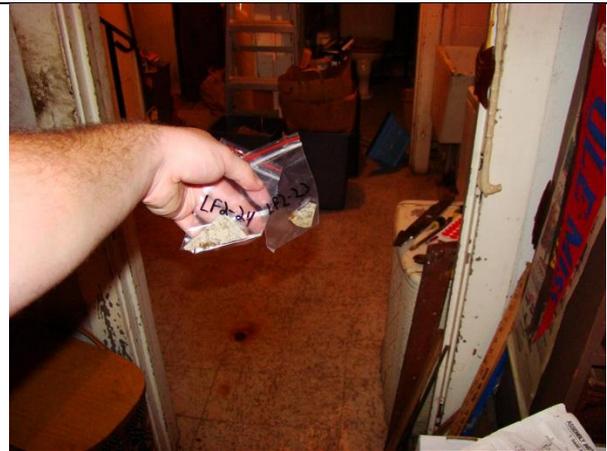
Lf2-24 and Lf2-25, Contains Asbestos

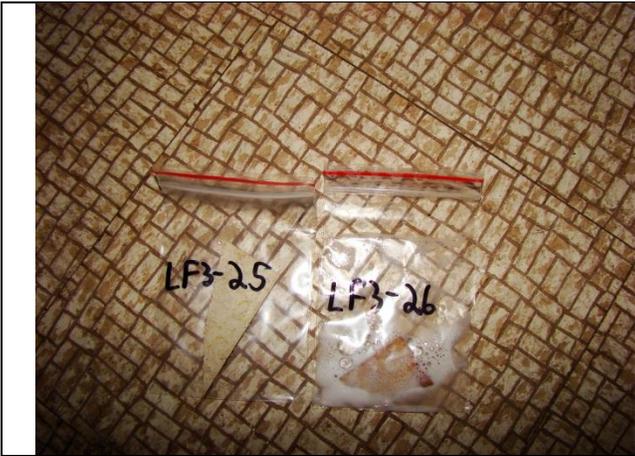
Lf3-25 and Lf3-26, Contains Asbestos

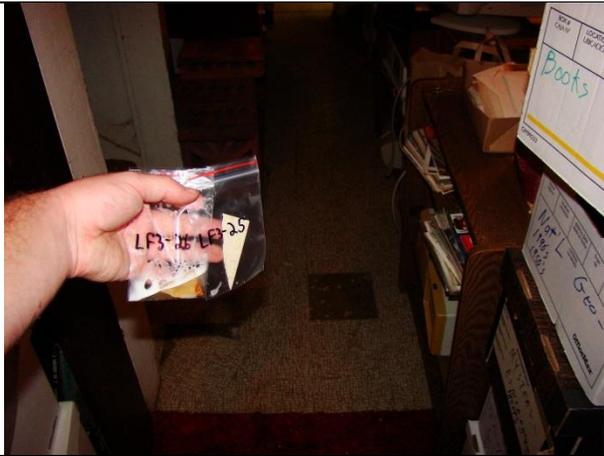
Lf3-25 and Lf3-26, Contains Asbestos

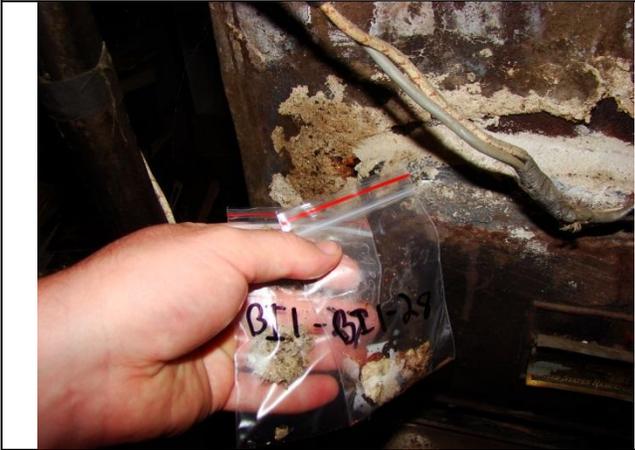
Bi1-27 and Bi1-28, Contains Asbestos

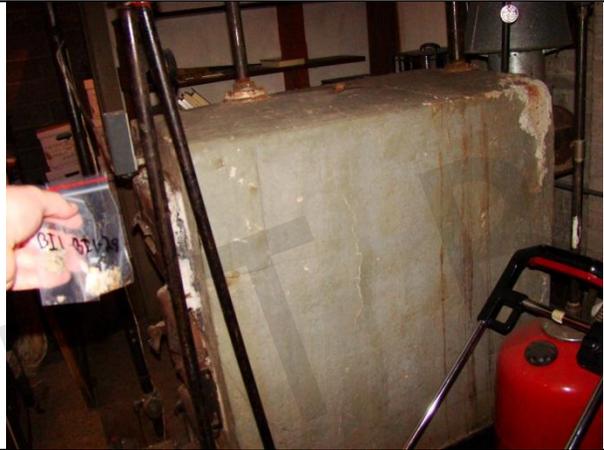
Bi1-27 and Bi1-28, Contains Asbestos

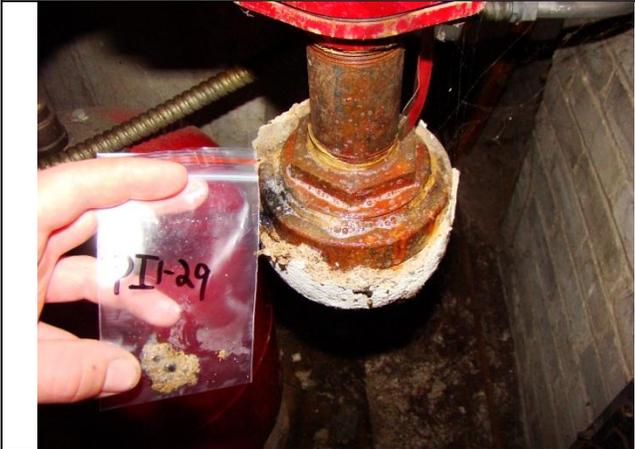
Pi1-29, Contains Asbestos

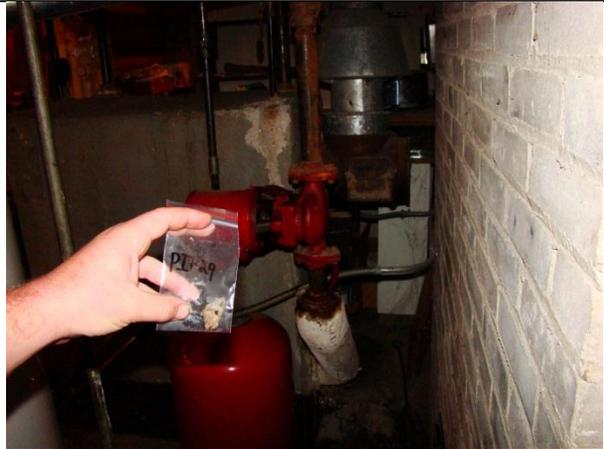
Pi1-29, Contains Asbestos

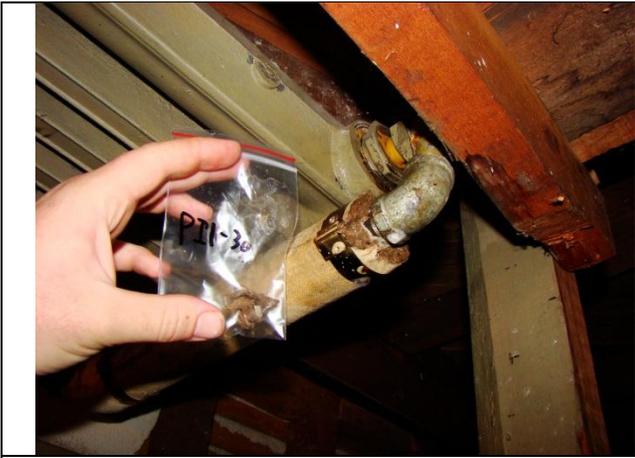
P11-30, Contains Asbestos

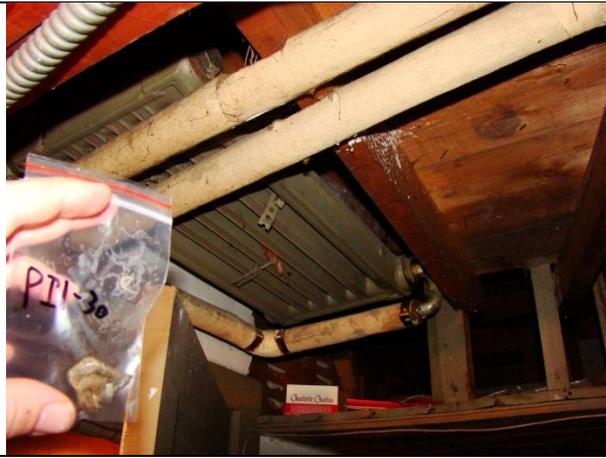
P11-30, Contains Asbestos

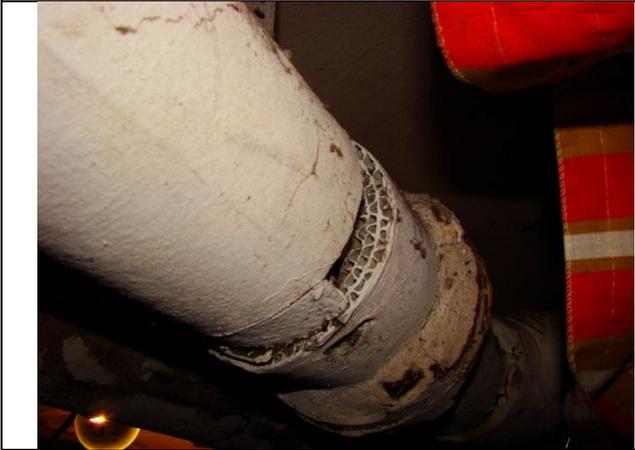
Asbestos Air cell Insulation

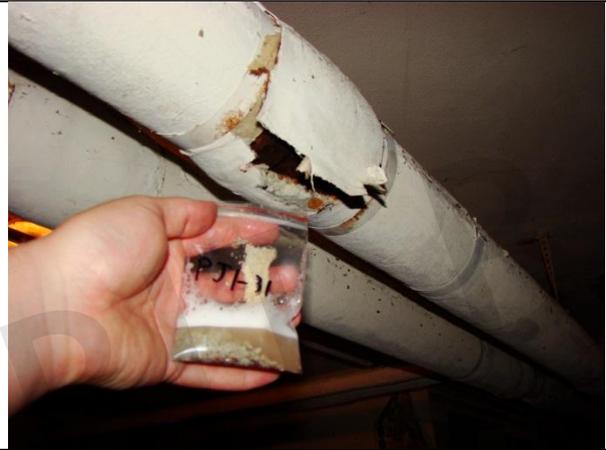
PJ1-31, Contains Asbestos

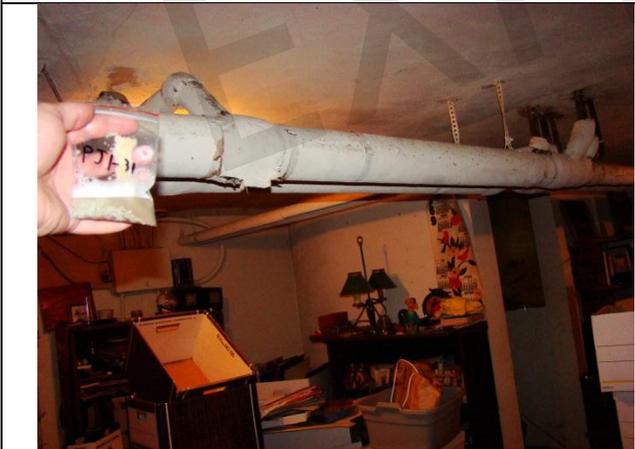
PJ1-31, Contains Asbestos

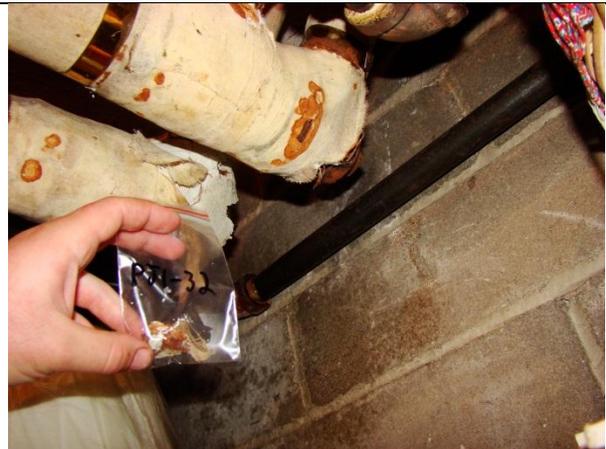
PJ1-32, Contains Asbestos

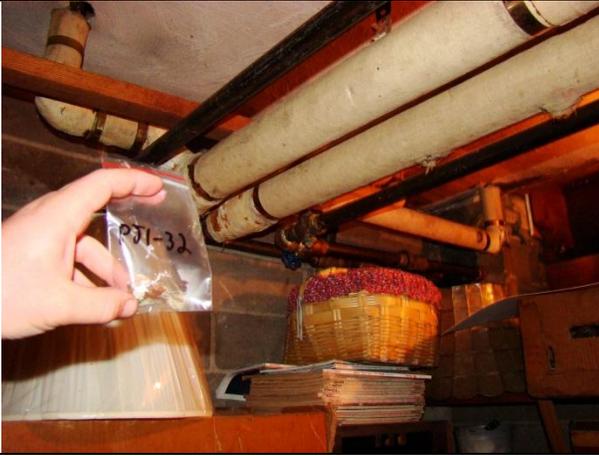
PJ1-32, Contains Asbestos

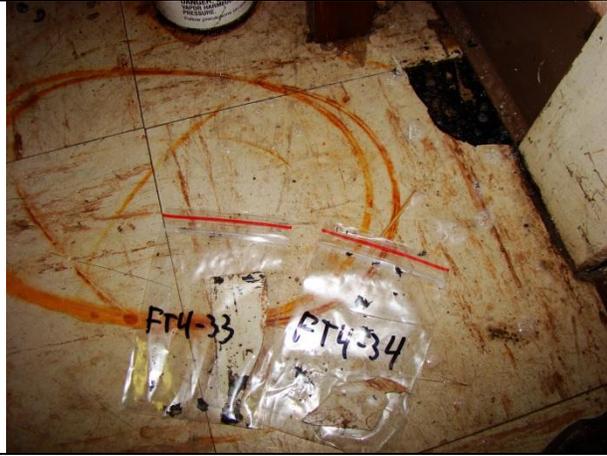
Ft4-33 and Ft4-34, Contains Asbestos

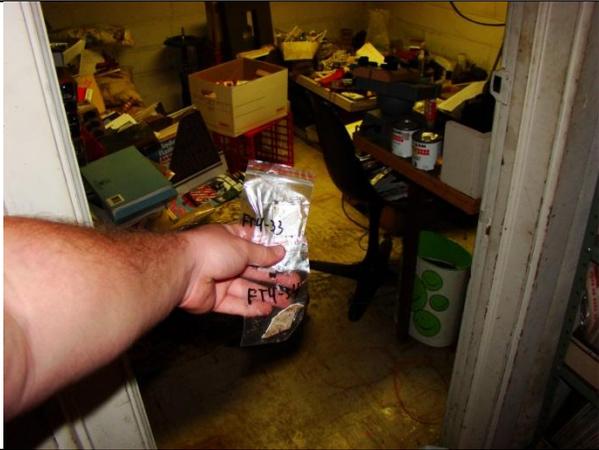
Ft4-33 and Ft4-34, Contains Asbestos

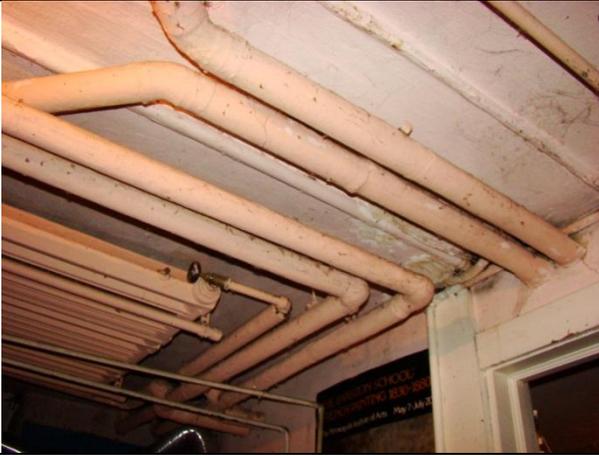
Asbestos pipe insulation in basement

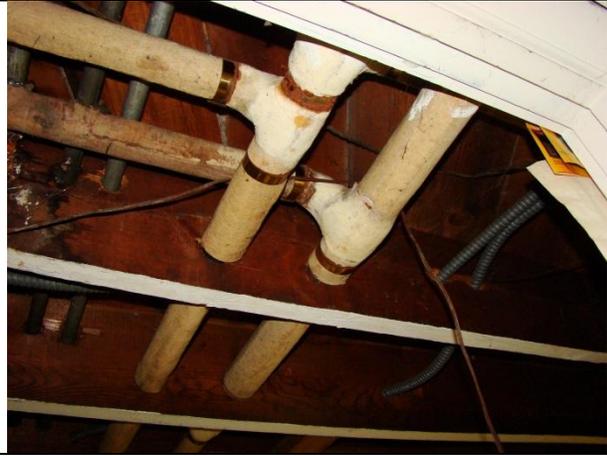
Asbestos pipe insulation in basement
