Environmental Profile  
Phase I Environmental Site Assessment  
Riverview Rd & 54th St E,  
Minneapolis, Hennepin Co, MN 55419

PN# 1-02212

**Plymouth Church Neighborhood Foundation**

**EnPro** Assessment Corp  
790 Cleveland Av S, Suite 211  
St. Paul, Minnesota 55116-1958  
(651) 645-6330  
[www.enproassessment.com](http://www.enproassessment.com)

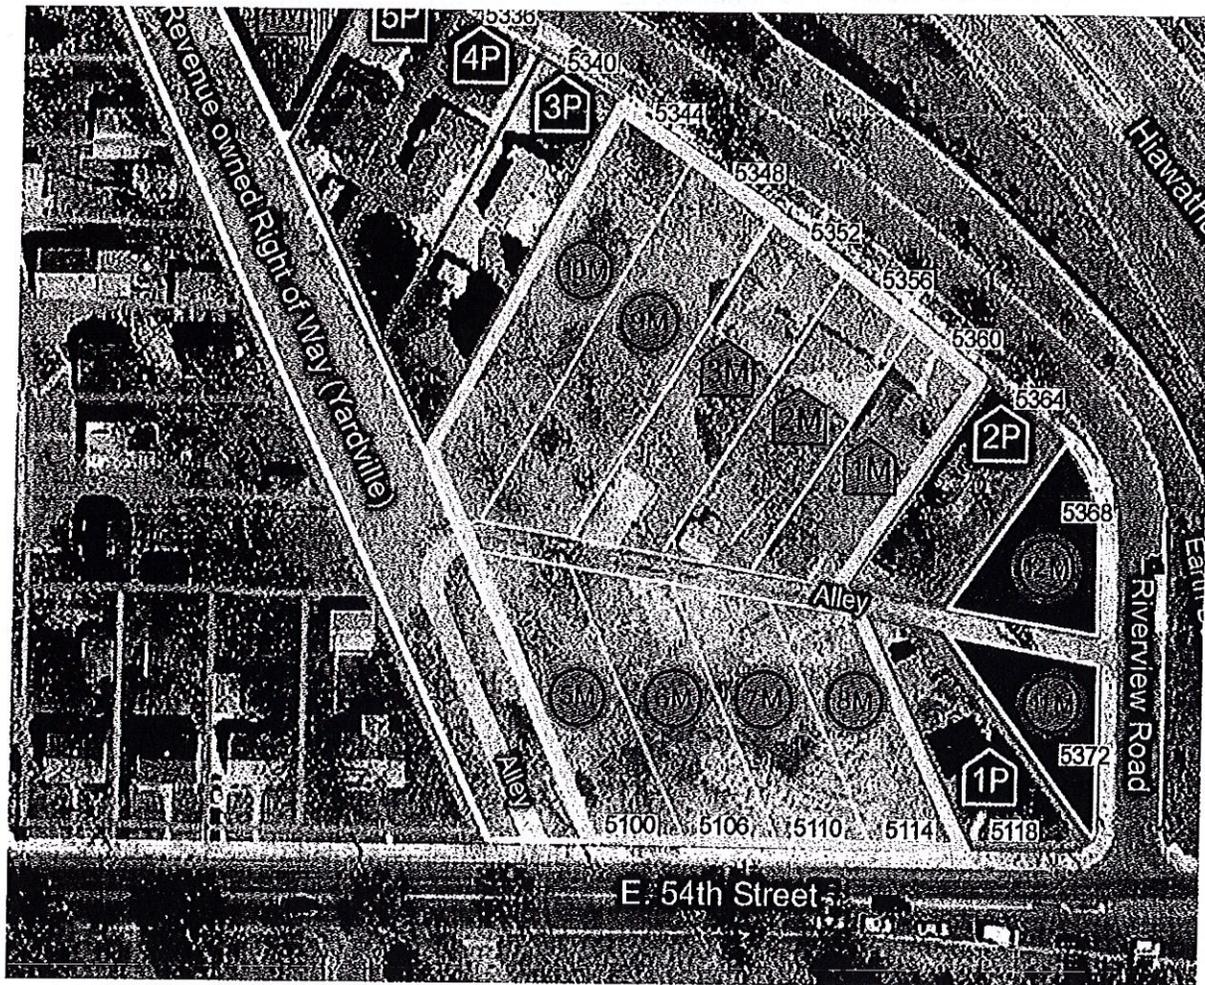
**Figure 2 Site Plan**  
**Environmental Profile**  
**PN# 1-02212**  
**Riverview Rd & 54th St E, Minneapolis, Hennepin Co, MN 55419**  
**EnPro Assessment Corp**

The site reconnaissance data are summarized in Figure 2, and the site reconnaissance worksheet is attached in Appendix 4.

The site is occupied by 3 single family residences on the northeast side.

**Exterior Toxic or Hazardous Materials** - There are no pipes, vents, or pads indicative of underground or above ground storage tanks. No other handling or storage of liquid, dissolvable, or leachable toxic materials is apparent. There are no apparent routes of entry to the subsurface except for exposed ground surfaces. There are no stains, odors, degraded pavement, stressed vegetation, or disturbed soils indicative of spills, leaks, or disposal.

**Adjacent and upgradient land uses** - Streets are adjacent to the north and south, and residences and an alley are adjacent to the east and west. The upgradient area is generally residential with a few commercial facilities.
