**North Star Lofts
Sign Rehabilitation Project
117 Portland Avenue South**

**Certificate of
Appropriateness Application**

**Minneapolis Heritage
Preservation Commission**

PROJECT:
 NORTH STAR LOFTS
 EXTERIOR SIGNAGE &
 SUPPORT RESTORATION

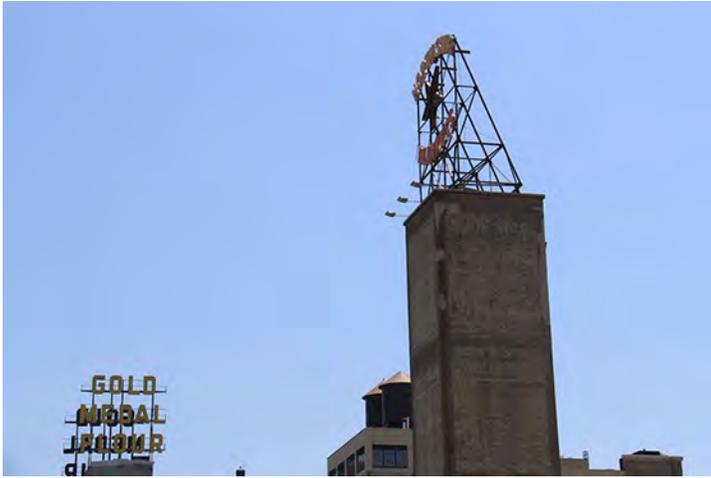
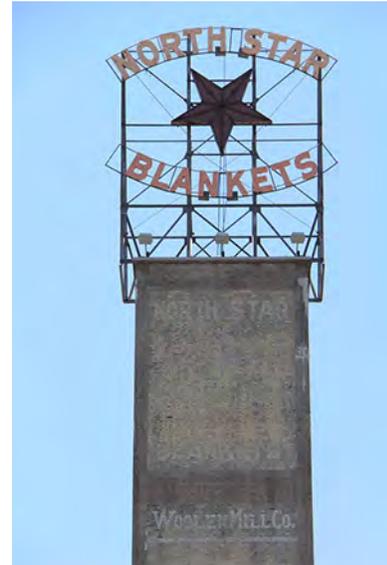
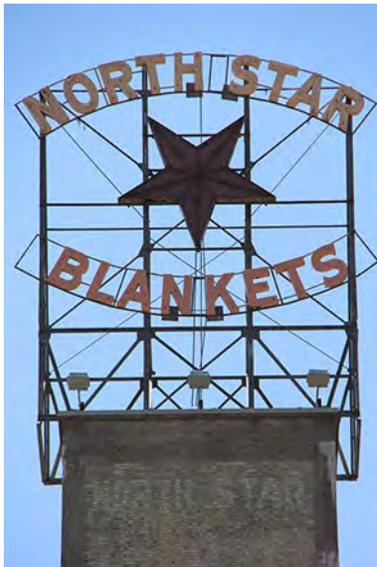
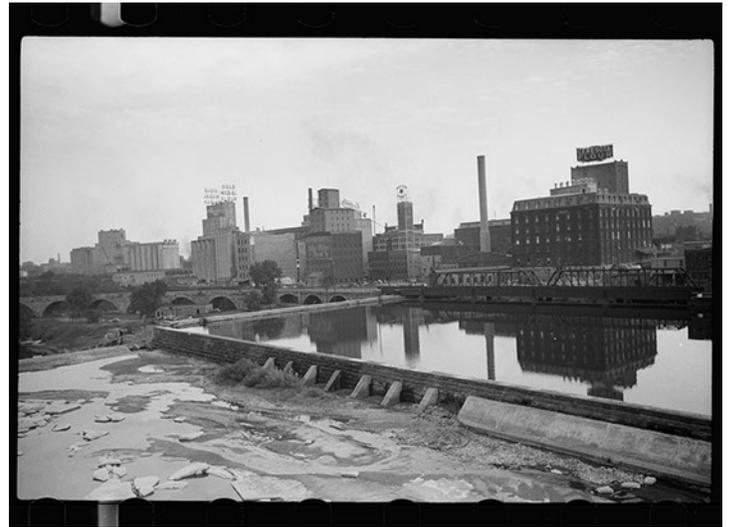
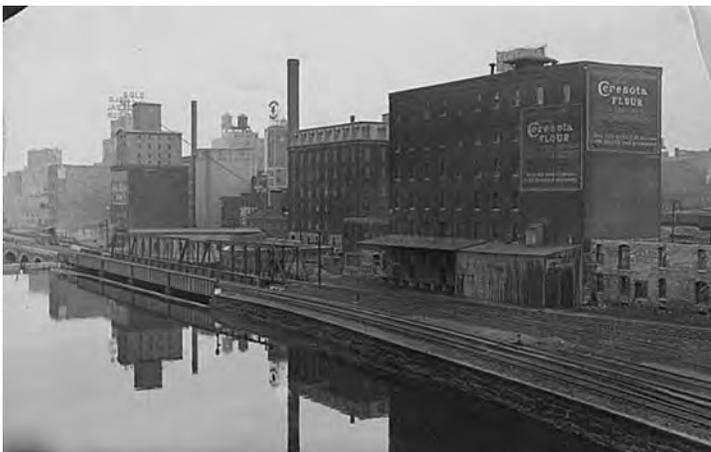
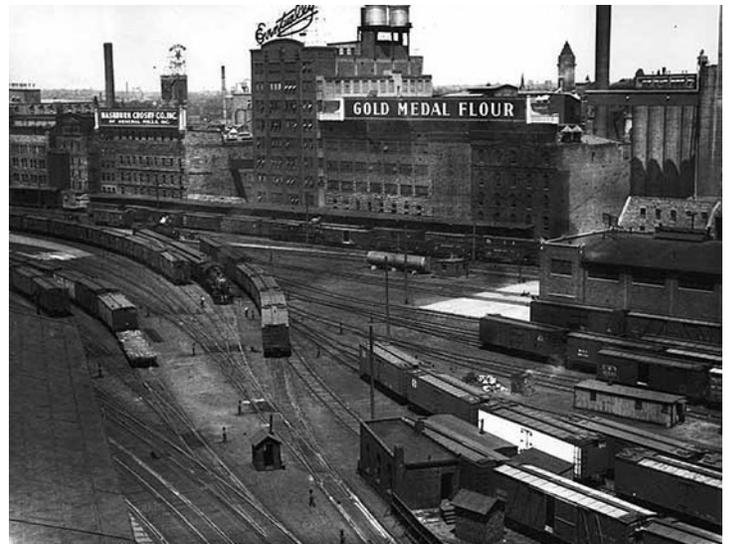
Existing feature/condition: A sign is attached to the south wall of the tower and another is attached to a frame on the roof. Both signs have a star and individual letters reading "NORTH STAR BLANKETS." The 3-D star and letters are made of painted sheet metal pierced with grommets for neon light fixtures. The neon tubes and most components of the lighting system are gone and the metal is rusted and deteriorating; sections are falling off.

Existing feature/condition: The frame is composed of steel beams and gusset plates bolted together. Most of the structure is painting and the paint is peeling. Rust is visible in many locations.

Existing feature/condition: Although no historic photographs of the lit sign can be found, remnants of a neon lighting system are visible on both signs. None of the neon tubes remain, and transformers and other equipment are in very poor condition. The signs are currently light by external floodlights.

Work plan: The sheet metal will be examined to identify rusted missing areas; deteriorated sections will be removed; new sections duplicating removed sections will be fabricated in sheet metal; historic metal will be cleaned using the gentlest means possible; replacement sections will be attached to historic sections. The metal will be primed and painted. The contractor will submit shop drawings for HPC staff review and approval before proceeding with the rehabilitation. The work will conform to *Preservation Brief 25: The Preservation of Historic Signs* and other relevant NPS publications.

Work plan: When the sign is removed for rehabilitation, the frame will be cleaned, primed, and repainted. Elements that are missing or very deteriorated will be replaced.

Work plan: If the budget allows, neon lighting will be incorporated into the signs as it was historically, or LED lighting will be substituted. The expense of neon or LED lighting is anticipated to exceed available funds, however, so while provision will be made for installing neon/LED lighting in the future, it is likely that the existing lighting will be retained for the present time.

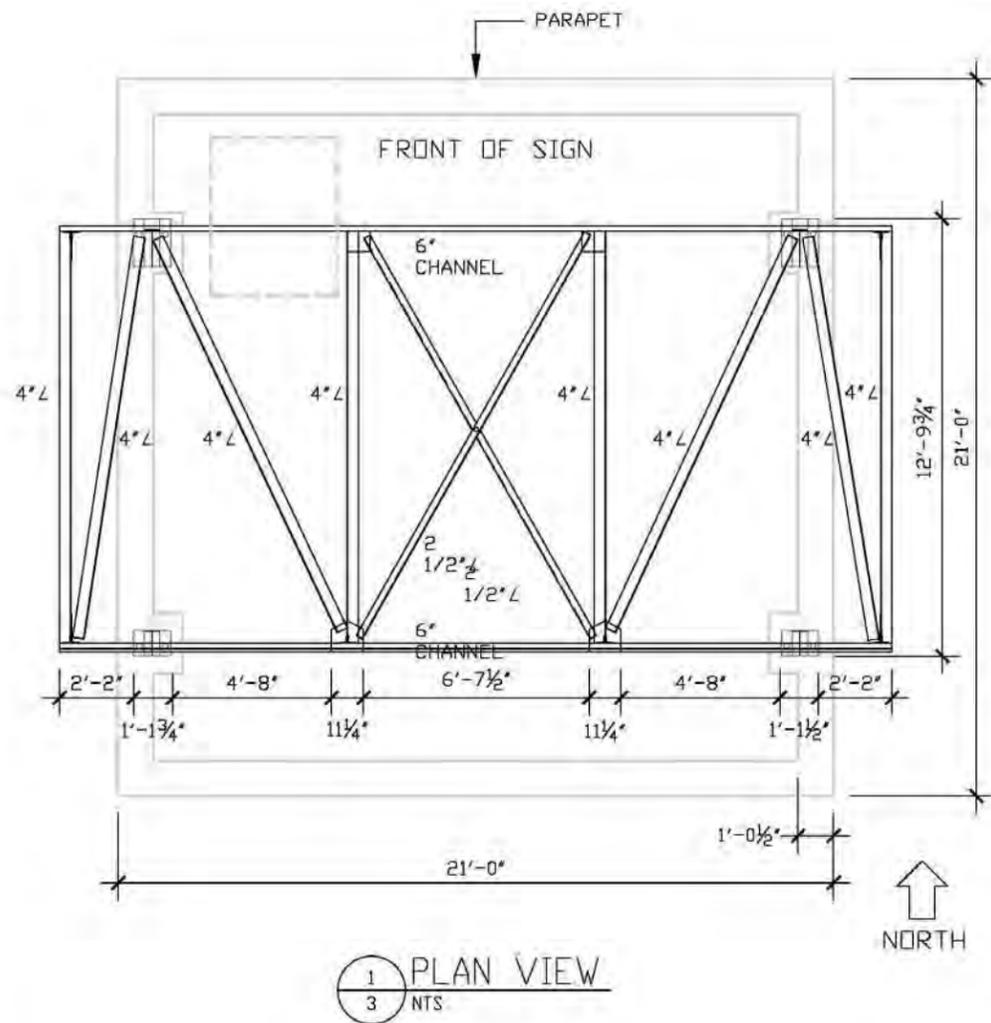
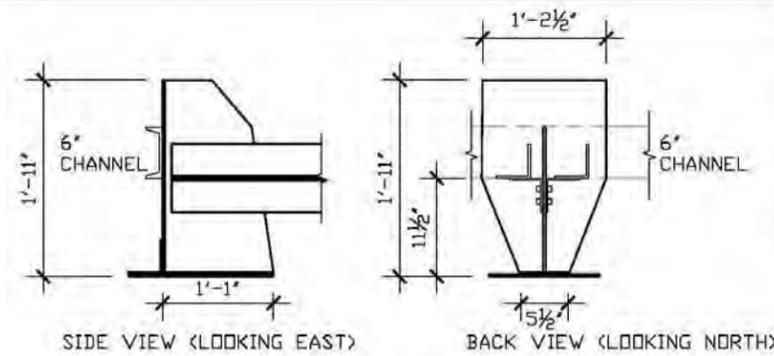
3 RIGHT-FRONT FOOTING

NOTE:
LEFT-FRONT FOOTING TYPICAL-MIRROR

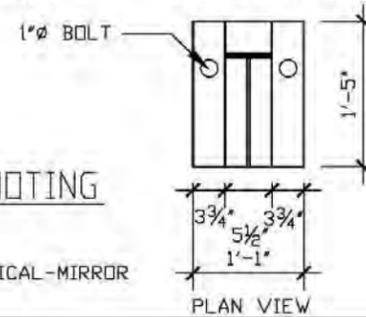
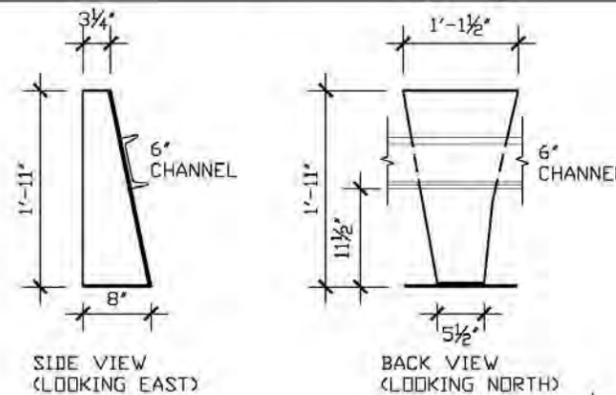
3 RIGHT-REAR FOOTING

NOTE:
LEFT-REAR FOOTING TYPICAL-MIRROR
