HERITAGE PRESERVATION APPLICATION SUMMARY

Location: 2418 Washington Avenue North
Landmark Name: North Side Station
Prepared By: Alex Young, City Planner, (612) 673-2118, with John Smoley Ph.D.,
 Senior City Planner, (612) 673-2830
Ward: 5
Neighborhood: Hawthorne
Request: To establish design guidelines for the North Side Station

NORTH SIDE STATION DESIGN GUIDELINES

2418 Washington Avenue North

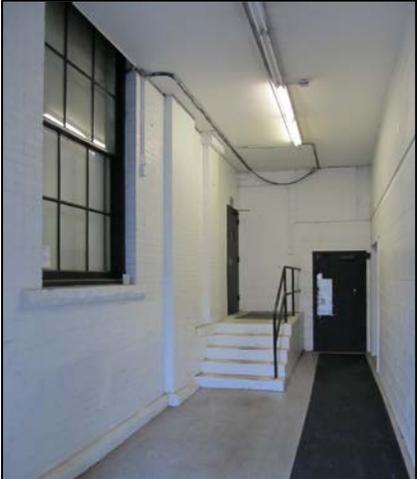
Enclosed Historic Main Entry

A. This language specifically refers to the historic main entry (Figures 3 - 7). At present, the entry is composed of a wide entry hall that was constructed adjacent to the 1954 addition. The 1914 building comprises the north side of the hall; the 1954 addition comprises the present entry door, the south enclosure of the hall and the eastern most enclosure to the entry hall. All surfaces, including the historic brick exterior of the 1914 building have been painted over in white paint. The 1914 portion is evident as painted over brick and the 1954 addition is evident as painted over concrete blocks. The former main entry and primary facade of the 1914 building consists of a former doorway opening that has been severely modified by the addition (Figures 4, 5, 7). Although the full extent of how this addition affected the 1914 building is unknown, there is some visual evidence of intact historic building materials.

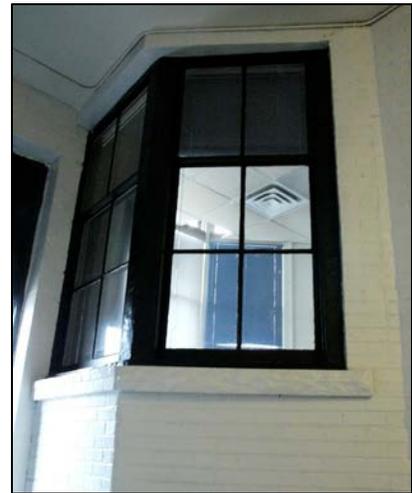
Enclosed portion of the bay window located in the interior by the main entry.

A. The five-sided bay window of the former foreman’s office on the southwest corner of the 1914 building’s office wing is an important part of this primary historic façade that has been partially enclosed by the 1954 bus garage addition (Figure 4-6). The windows are presently in a deteriorated condition, in the event of any restoration; these features shall be repaired rather than replaced. Where the severity of deterioration requires replacement of a distinctive feature, the new feature should match the original in design, color, texture, and, where possible, materials.

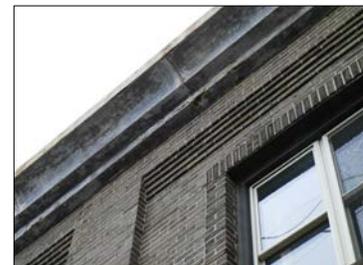
Metal cornice at the roofline

A. The metal cornice is likely original and is in a deteriorated condition (Figure 1, 2). It should be preserved, repaired and only as a last resort be replaced in kind if none of the other options are viable.

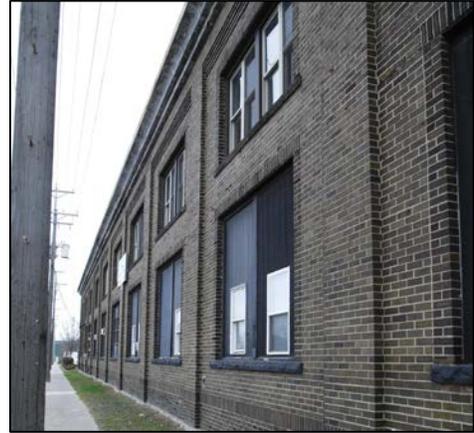
Infill panels and replacement windows.

- A. The primary façade along Washington Avenue North contains modern vinyl replacement windows and infill wood panels in all of the window openings (See Figure 98 and image at right). Any replacement of these windows or panels should move towards the historic appearance and features of the building. (See image at right.)

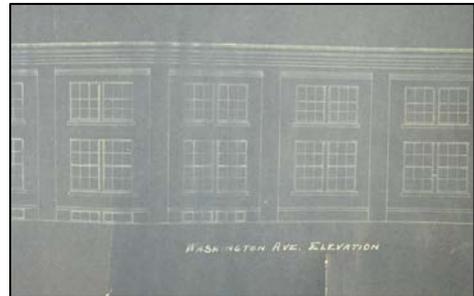
Original 6-over-6, double-hung divided light windows.

- B. As seen in historic photographs and in the original building elevation drawings, the majority of the windows were wooden, six-over-six, and three-over-six double hung sashes with four over four double hung sashes in the foreman's office bay window. Transom windows over the bay doors were fixed windows with six divisions of lights (See Figure 3 and image at right). Many of these transom windows are presumably original, yet in a deteriorated condition. These shall be preserved, repaired or replaced in kind, with replacement as a last resort. Where the severity of deterioration requires replacement, the new feature should match the old in design, color, texture, and, where possible, materials.

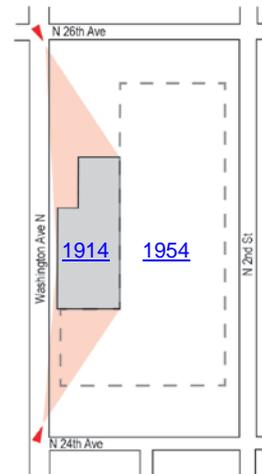
Important view sheds of 1914 building, [south façade](#) blocked by the addition

- E. Future redevelopment of the block should consider retaining some open space behind the North 2nd Street façade. The 1914 portion of the building occupies a small portion of the site. A north / south alley cut through the block could provide for new uses and accessibility to future occupants of any new construction on this site. In this scenario, North 2nd Street could be redeveloped using either portions of the 1953-54 bus garage addition or entirely new construction. Portions of North 24th and North 26th Avenues could also be redeveloped for future uses.

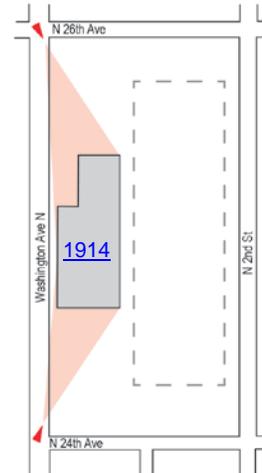
Retaining view sheds and open space behind. Area for future development shown in dashed box.

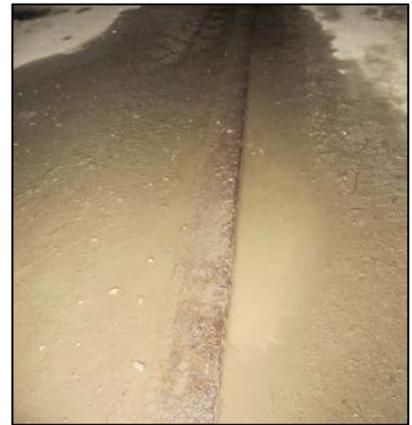
Exposed streetcar tracks in the former car sheds

Within the sheds, historic streetcar tracks are faintly visible. While the designation does not mandate the preservation of this material, it is an important feature of this property. Within any future [rehabilitation changes](#), the preservation of this particular feature is encouraged. In addition to the tracks, within the 1914 portion of the building there are various other materials and features that date to the building's period of significance. Materials such as the exposed hollow core fireproof bricks and the steel trusses in the streetcar sheds are unique features that tell the story of this building. Old fire doors and other materials dating to the period of significance are likely hidden by layers of non-historic alterations. This may present both opportunities and challenges to designers and craft persons in the future who perform maintenance and rehabilitation work. While alterations over time have resulted in a loss of interior integrity that does not make the building suitable for interior designation, retention of any existing historic materials on the interior will likely add to the uniqueness of this building. The retention of materials and elements found in the interior that date from the period of significance is **encouraged**, but is not mandated.

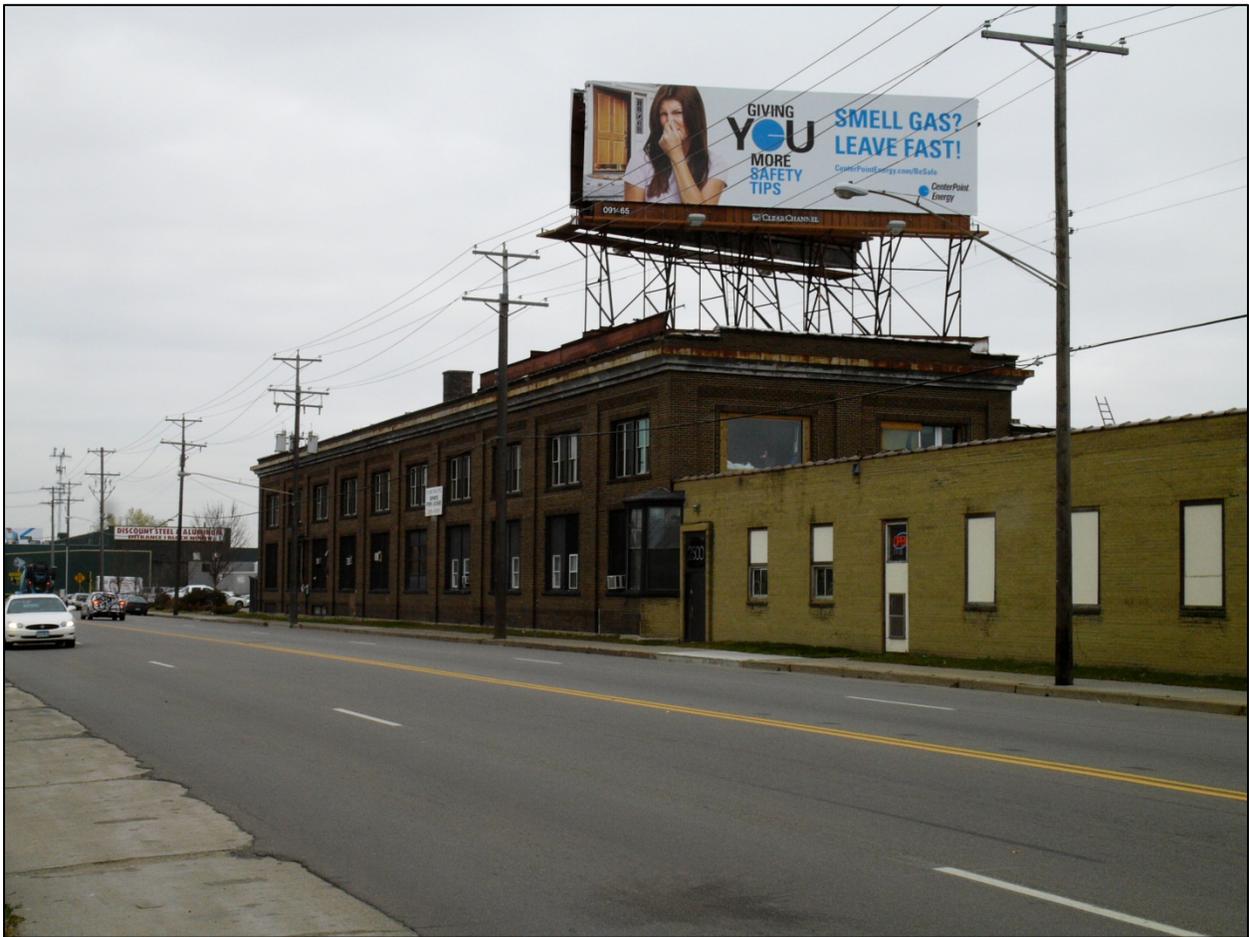
Figure 1. North Side Station, Washington Avenue North frontage, view from the southwest. Note the billboard on top of the 1914 building, the deteriorated cornice, the 1954 addition in light tan brick adjacent to the protruding bay window. Note also the replacement windows and wood panel infill. Source: CPED files.

- The building's brick walls and fenestration pattern (Figures 1, 2, 3)
- The building's metal cornice (Figures 1, 2, 3)
- The building's flat roof (Figures 1, 2, 3)
- The main entry and foreman's office bay window (partly enclosed by the 1953-54 addition) (Figures 4, 5, 6, 7)

- A. The billboard installed on the roof of the office wing portion of the building is not an historic feature (Figure 1). While its removal is not mandated, it is assumed that someday it will no longer be in use. Maintenance and removal of this billboard shall take care not to harm any historic building materials.

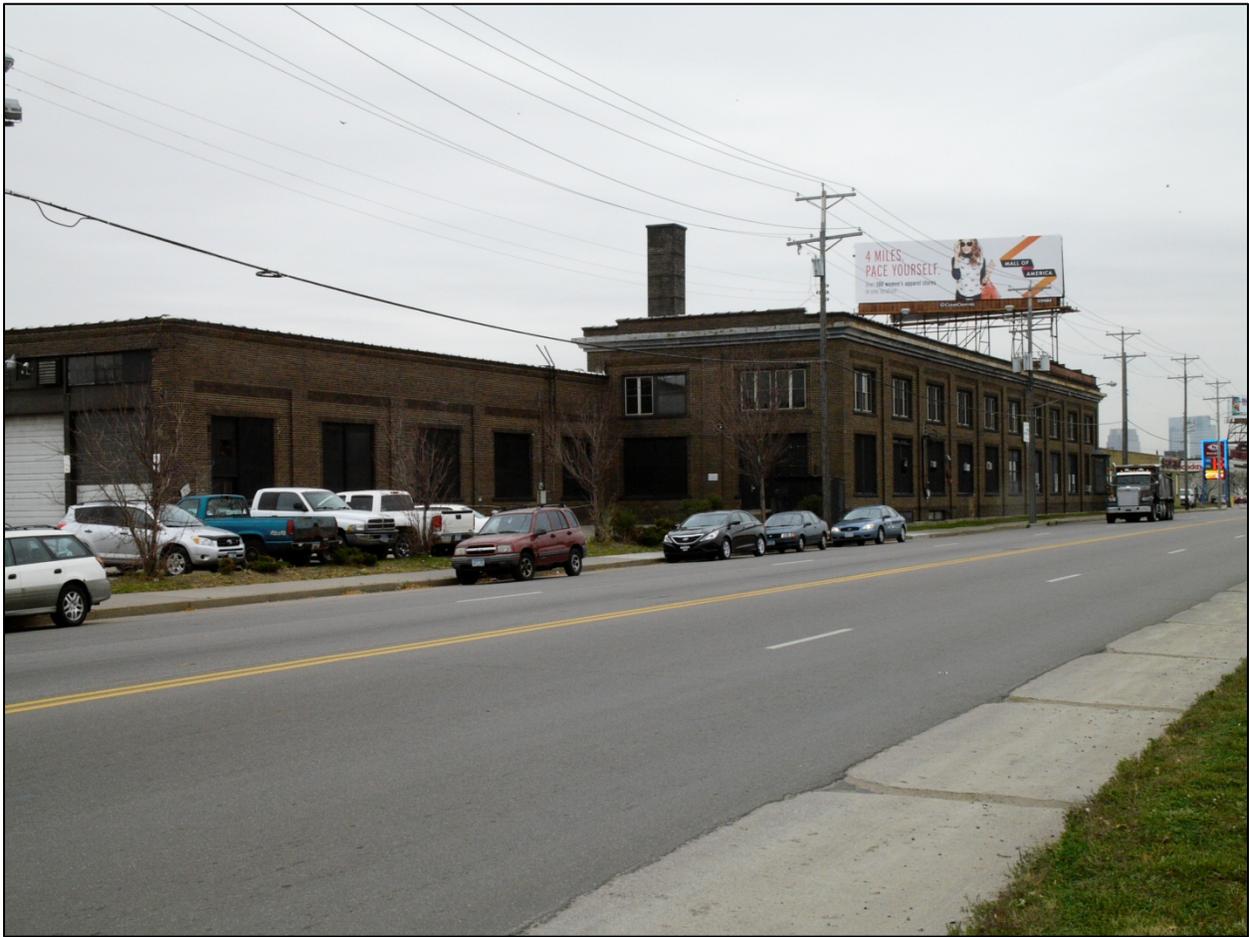
Figure 2. North Side Station, Washington Avenue frontage, view from the northwest. Note the chimney, the parapet, the metal cornice, the wood infill panels and replacement windows and shed bay doors. Source: CPED files.

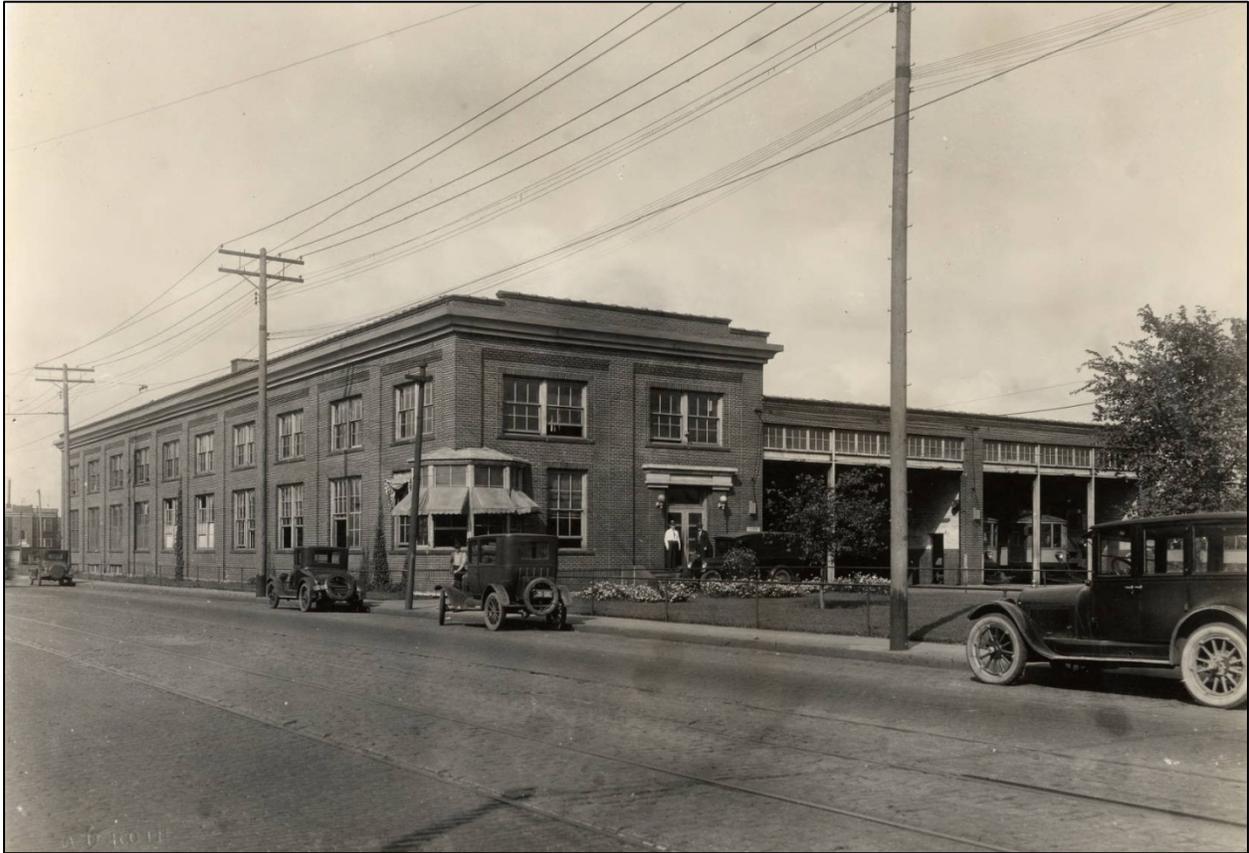
Figure 3. North Side Station 1922. Note the five-part bay window, the main entry, the shed car bays, the divided light windows and the open space in front of this part of the building. Any ~~alterations-changes~~ to the exterior of the 1914 building and any partial or complete demolition of the 1954 addition should move to restore the building back to this form. Source: Minnesota Streetcar Museum.

[the south facade](#), this area should [become](#) the main entry of the building and should be restored to the form and appearance of the entry from 1914 – 1953 (See Figure 3).

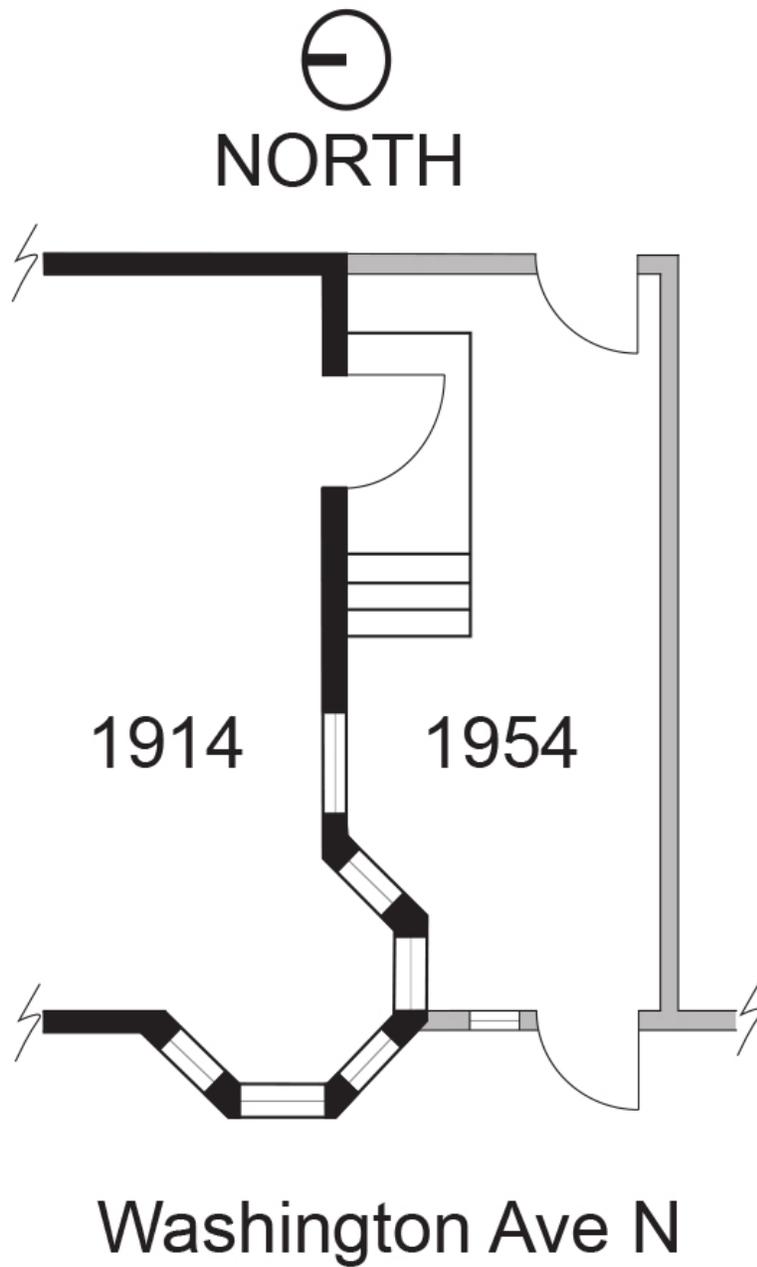
Figure 4. North Side Station – main entry condition at present. The main entry of the 1914 building is enclosed by the 1954 addition as shown by this diagram in plan view.

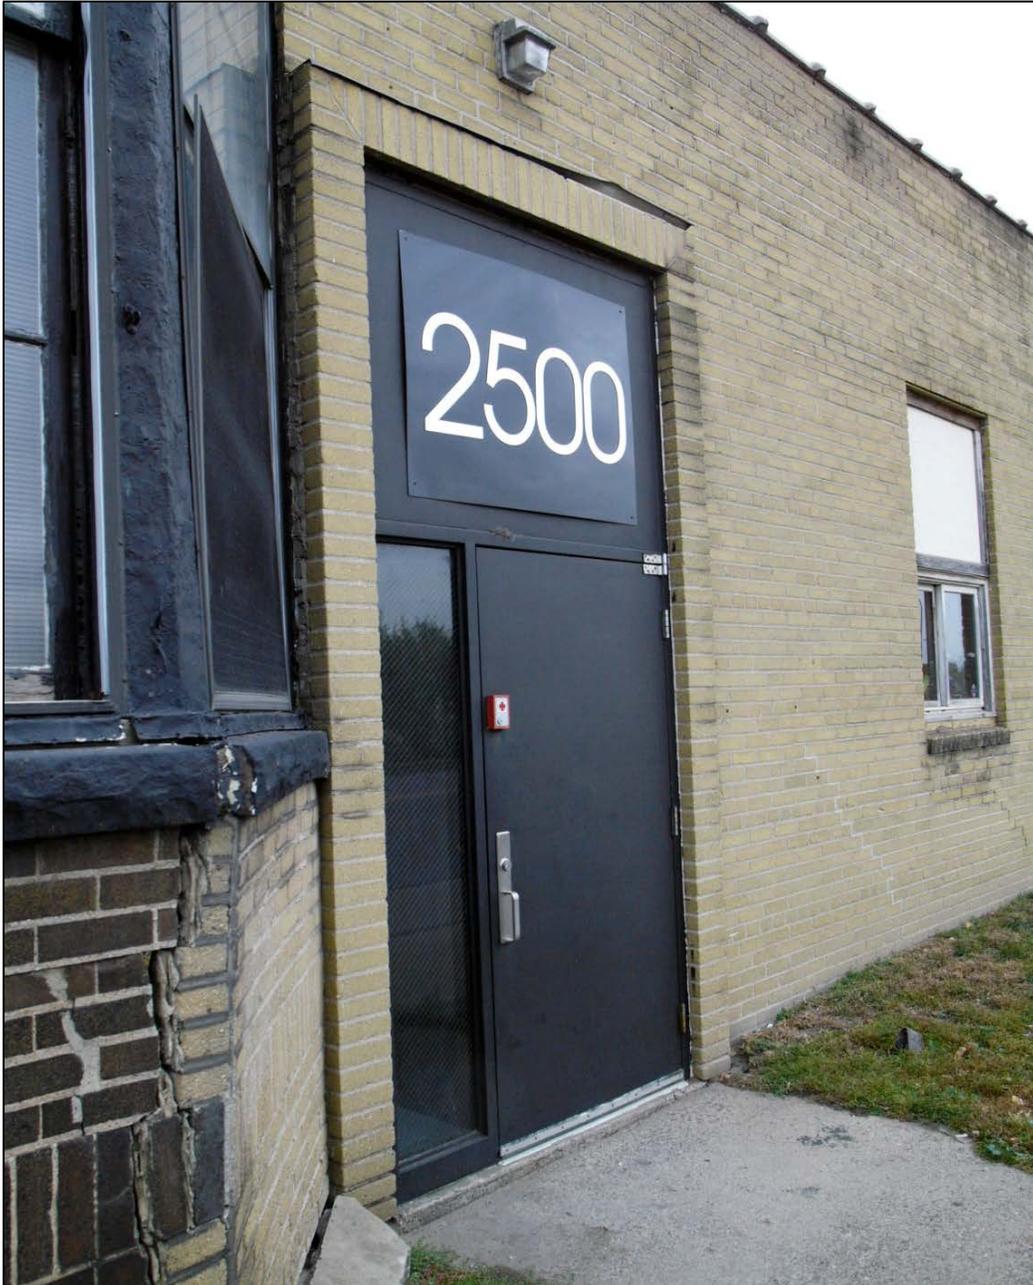
Figure 54. Main entry off of Washington Avenue. Note the use of tan brick in the bay window; the addition envelops the south exterior wall of the 1914 building. Source: CPED files.

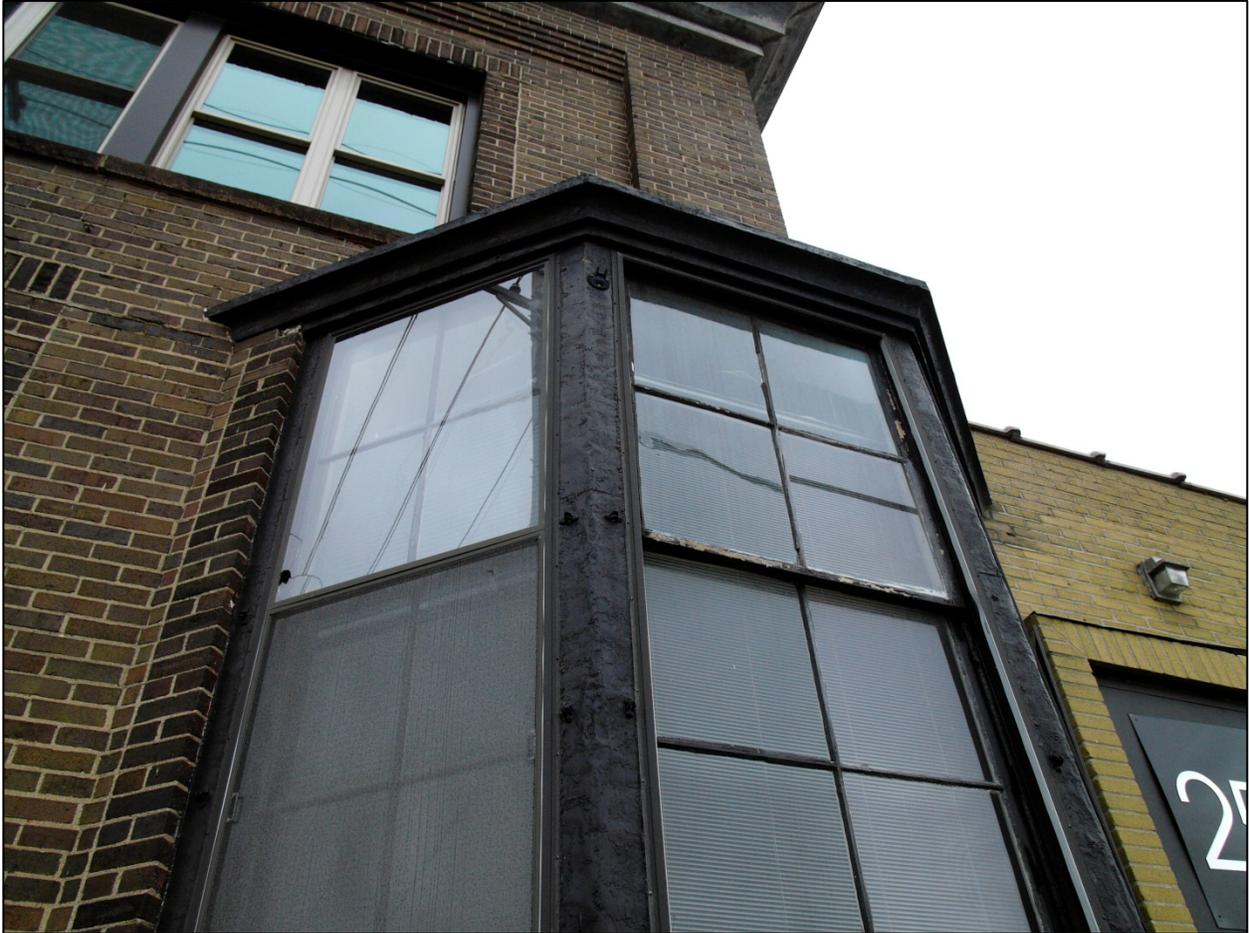
Figure 65. Portion of the five-part bay window that protrudes outside of the present entry. Source: CPED files.

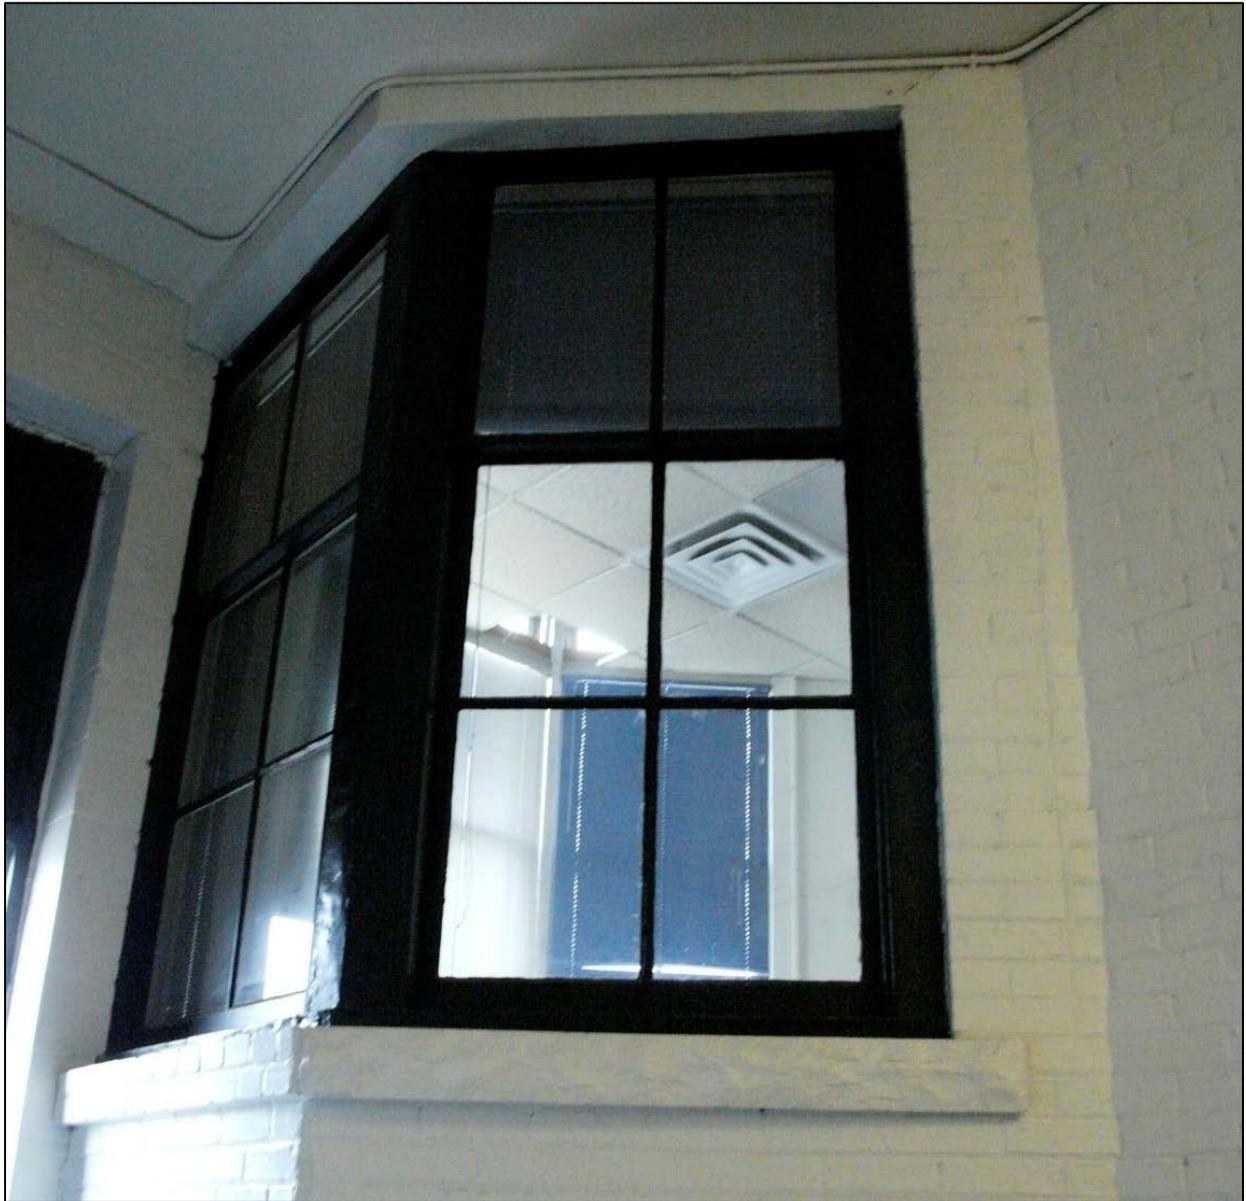
Figure 76. Interior portion of the five-part bay window enveloped by the addition into the present main entry.
Source: CPED files

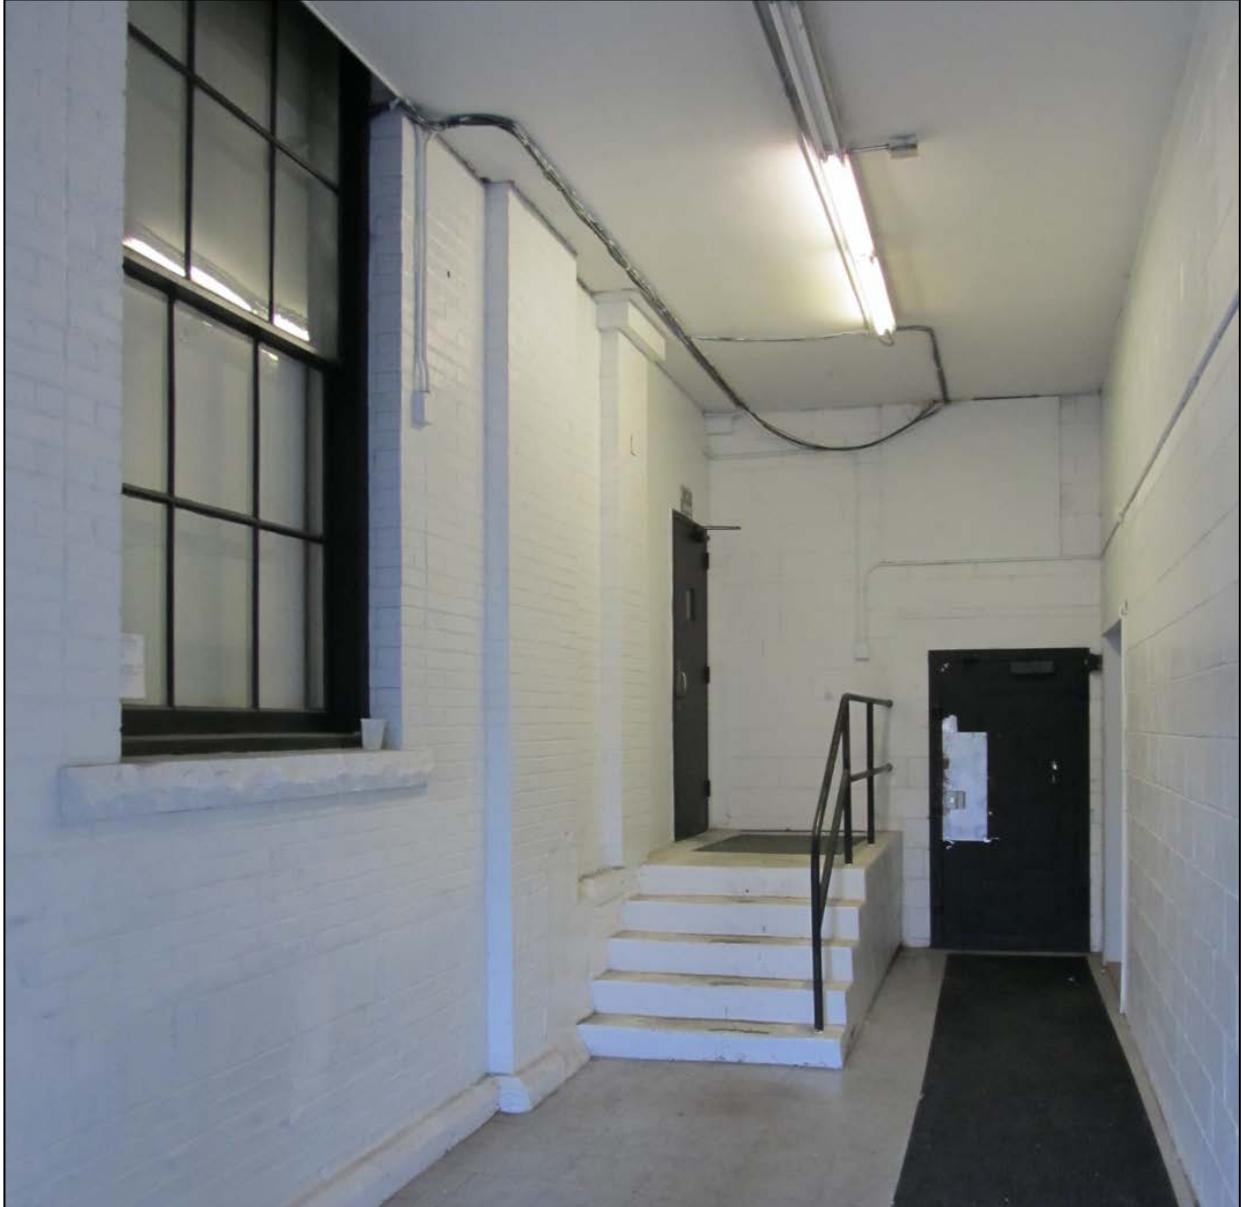
Figure 87. Present main entry, interior. The 1914 exterior wall including former main entry is to the left. The ceiling, the far wall and wall to the right are from the 1954 addition. Source: CPED files.

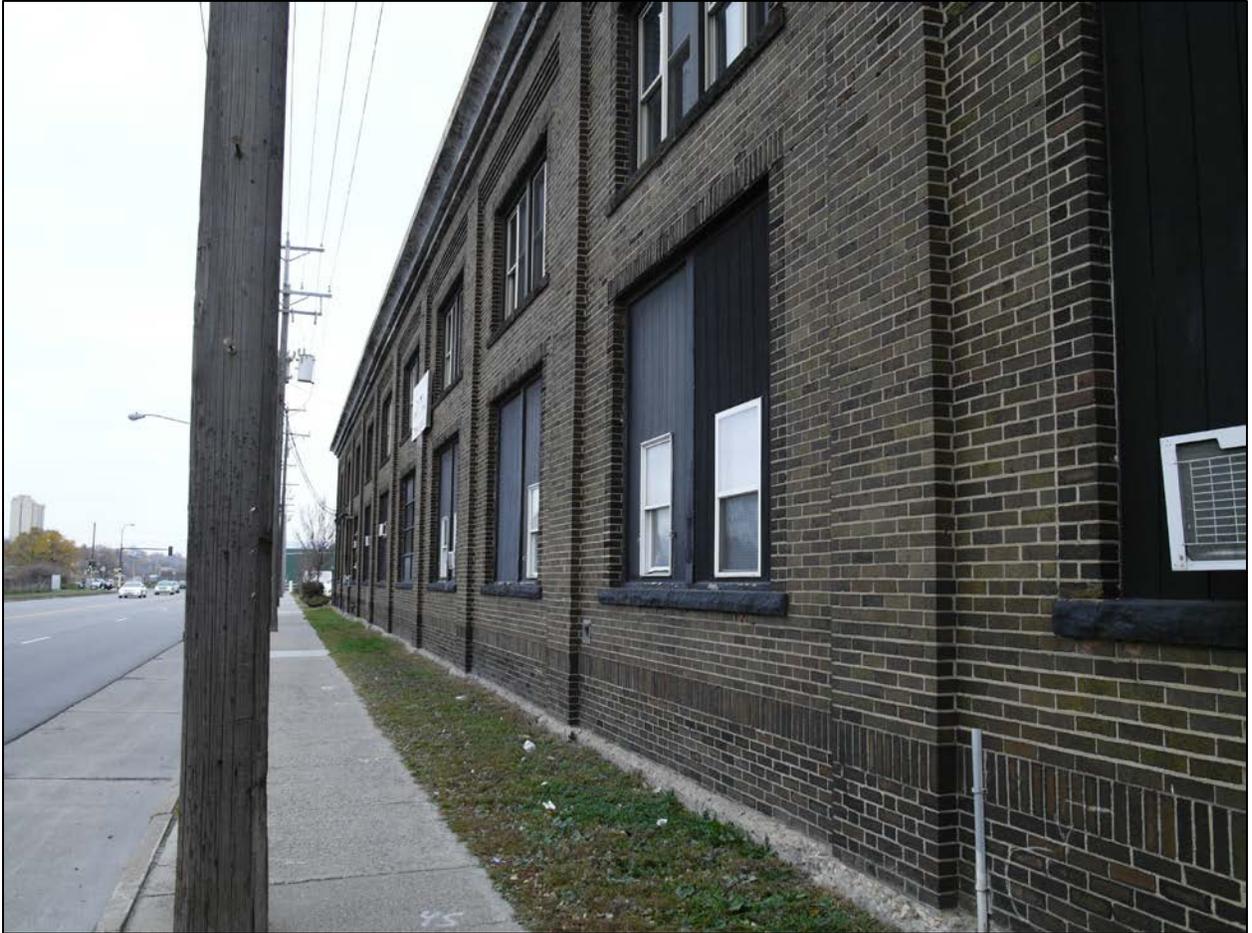
Figure 9.8. Infill panels and replacement vinyl windows on 1914 building. Source: CPED files.

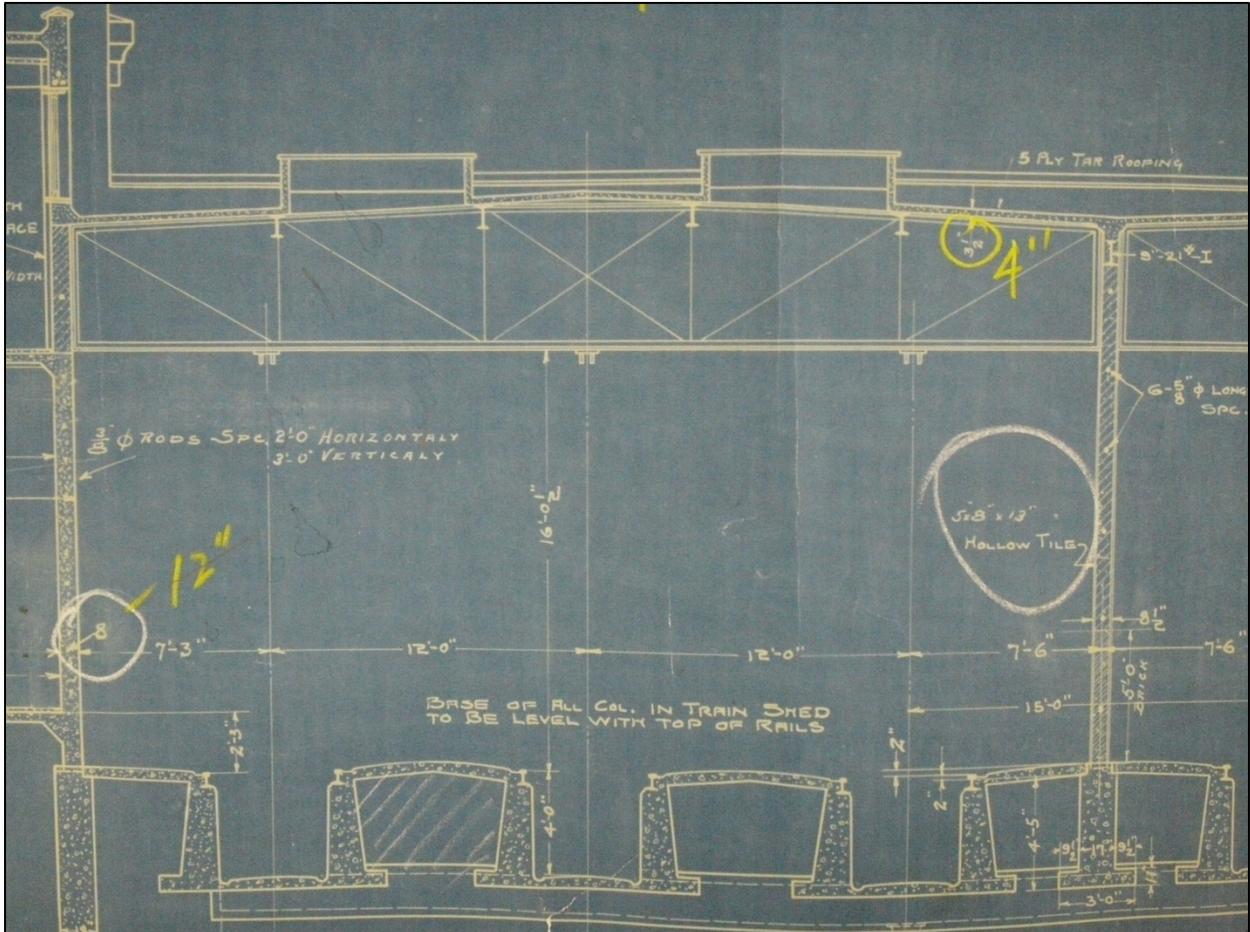
Figure 109. Section drawing - detail of streetcar maintenance sheds, note skylights, trusses, and tracks. Source: Northwest Architectural Archives, University of Minnesota.

- C. The streetcar storage sheds employed skylights to provide natural light into the maintenance sheds of the 1914 building (Figure 108). These openings have since been altered and are now covered. Any future rehabilitation or use of this space should consider a restoration of these skylights as a primary way to bring natural light into this space. This feature does not in any way restrict the addition of artificial lights.
