City of Minneapolis
*Department of Community Planning
& Economic Development - CPED*

MEMORANDUM

TO: Heritage Preservation Commission
FROM: John Smoley
DATE: August 31, 2010
RE: Conceptual Review, American Swedish Institute interior, site, and building changes

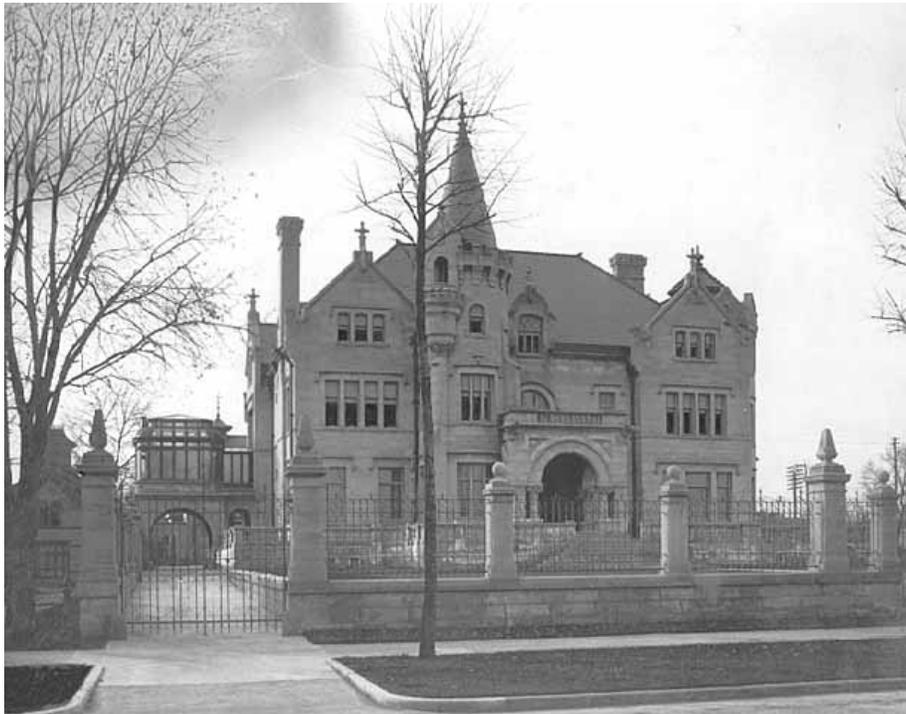
Figure 1. 2600 Park Avenue under construction, 1907, photo courtesy of Minnesota Historical Society

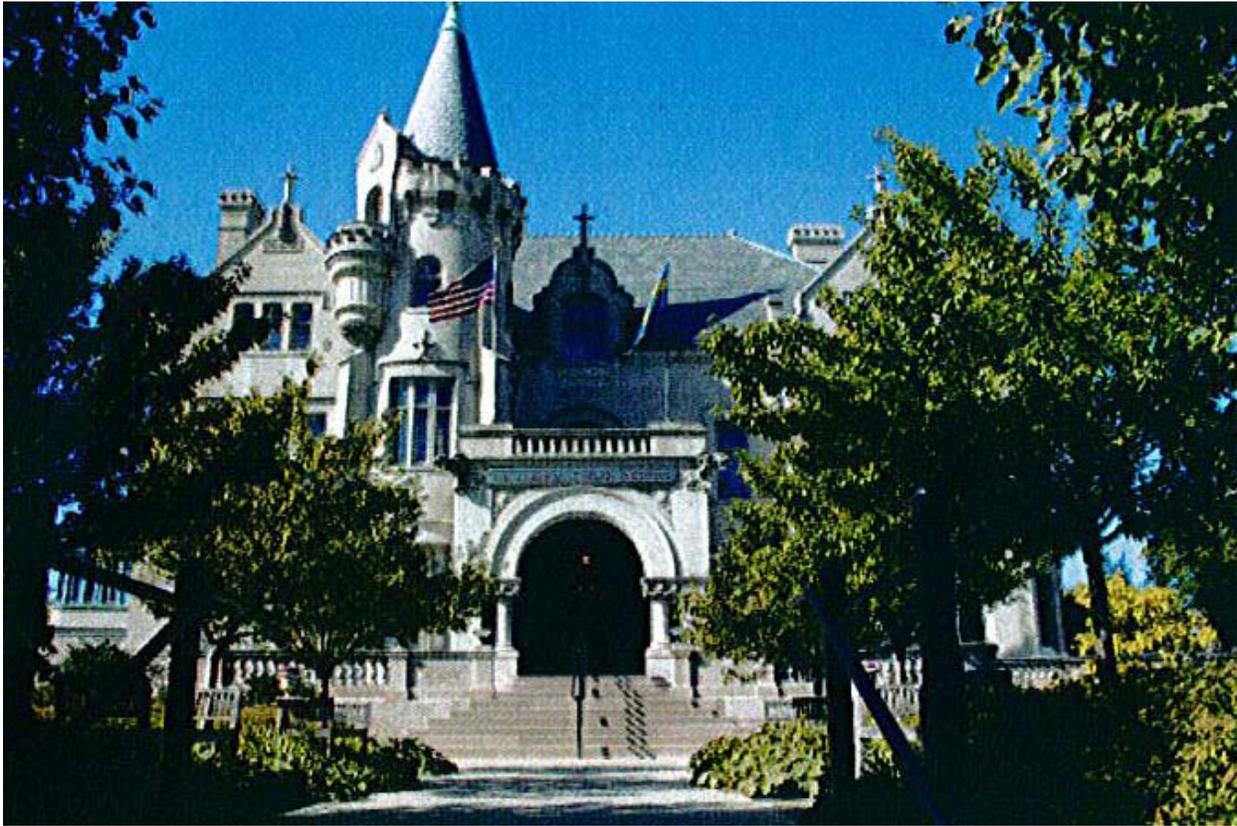
Figure 2. 2600 Park Avenue, 2010, photo courtesy of Applicant
