Demolition of a Historic Resource Application

Subject Property: 4535 Lake Harriet Parkway East

As requested, we completed a structural condition review including a site observation on September 12, 2013 in order to provide opinions and recommendations based on our available information in regards to the structural remediation required at the 4535 Lake Harriet Parkway single family residence.

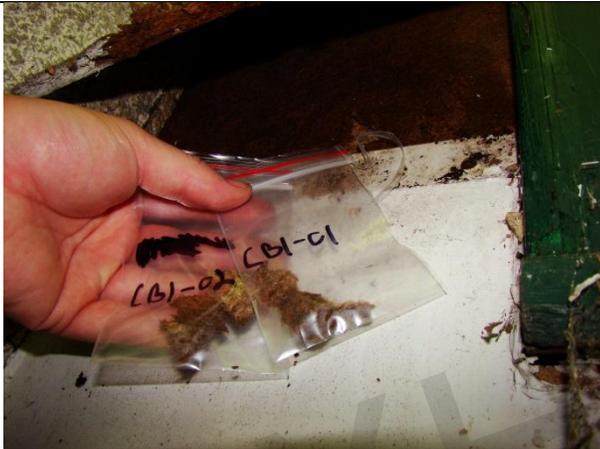
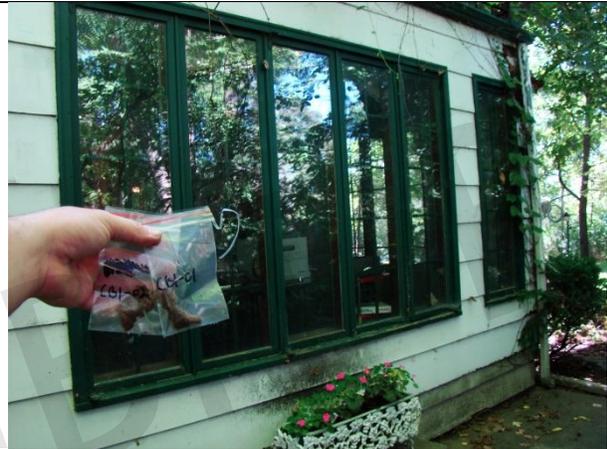
Cb1-02 Cb1-02, no asbestos

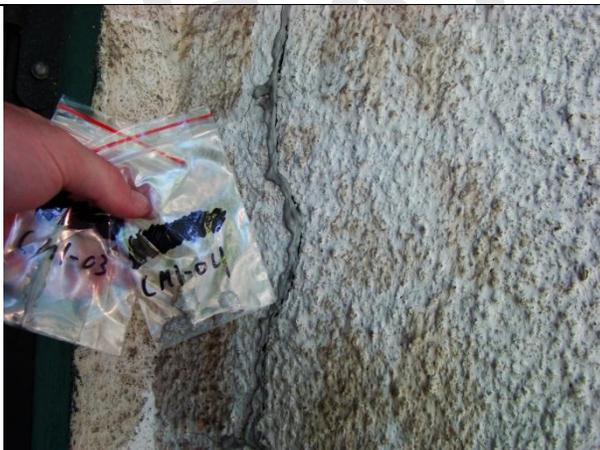
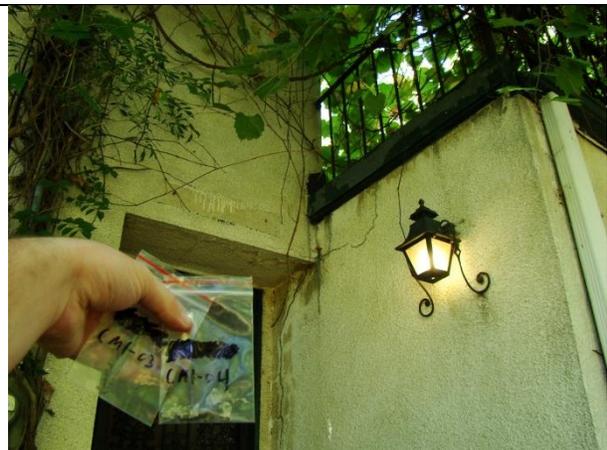
Cm1-03 and Cm1-04, no asbestos

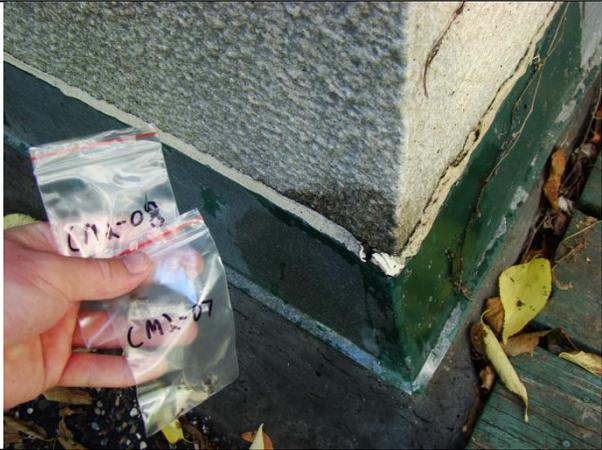
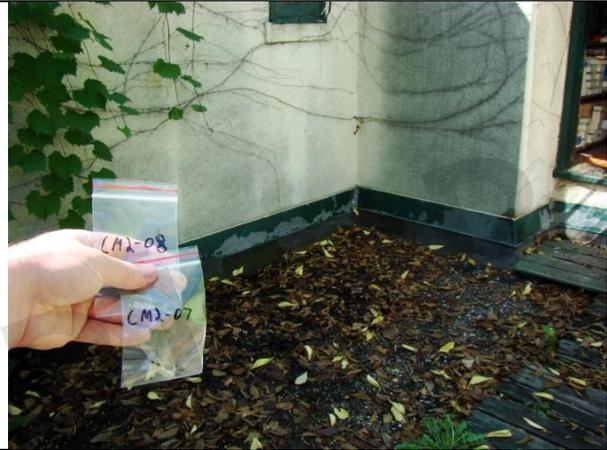
Cm2-07 and Cm2-08, no asbestos

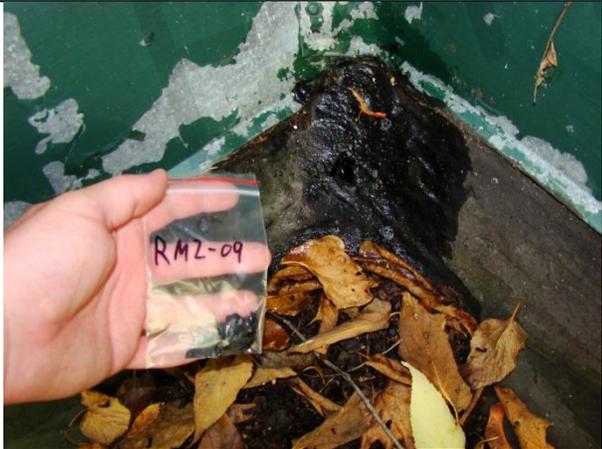
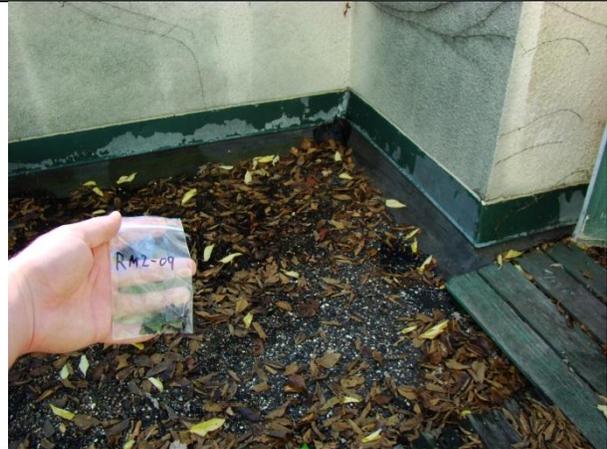
Rm2-09, no asbestos

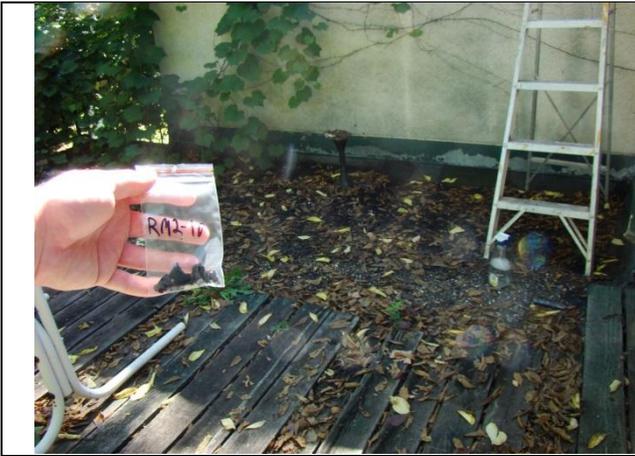
Rm2-10, no asbestos

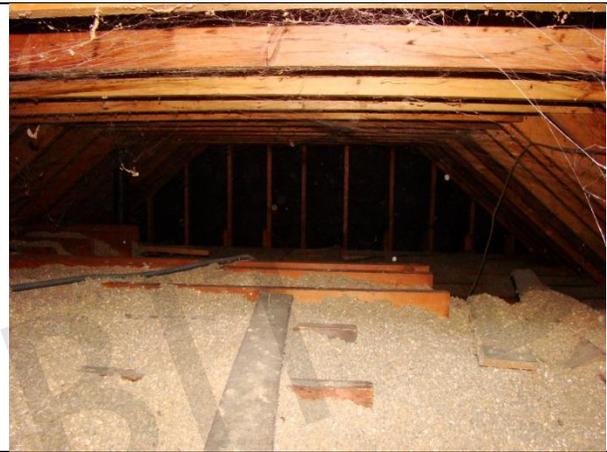
Attic, no vermiculite insulation

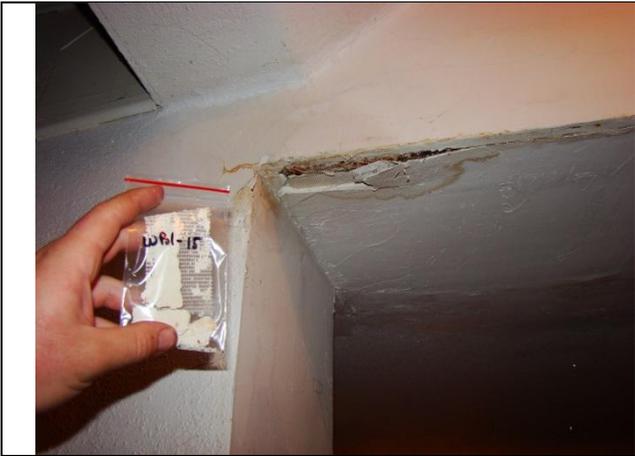
Wb1-15, no asbestos

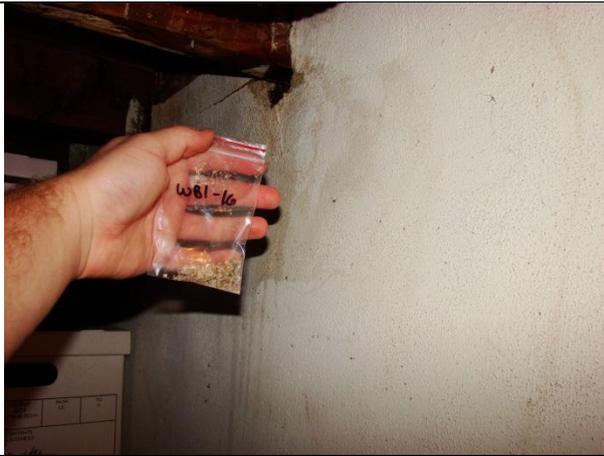
Wb1-16, no asbestos

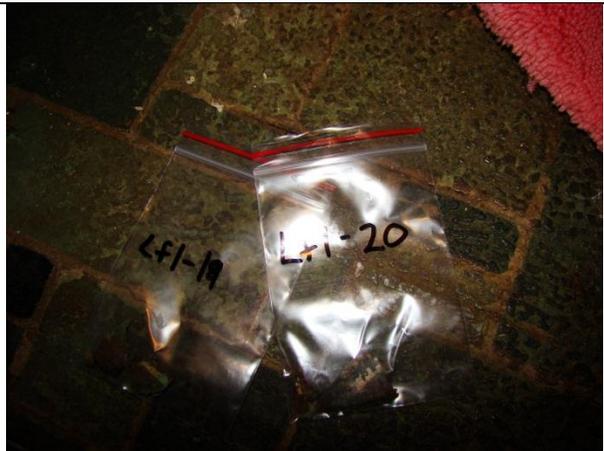
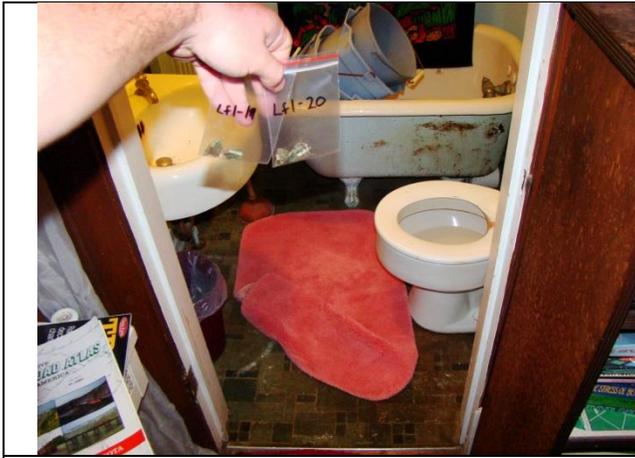
Lf1-19 and Lf1-20, no asbestos

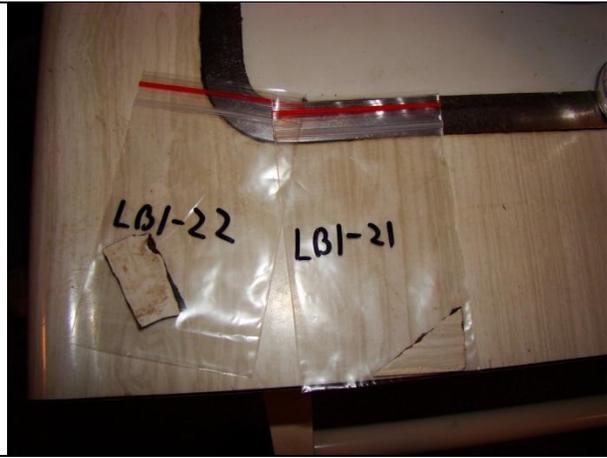
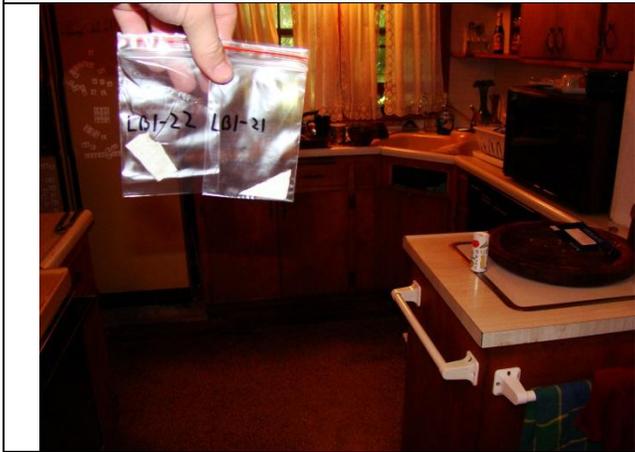
Lb1-21 and Lb1-22, no asbestos

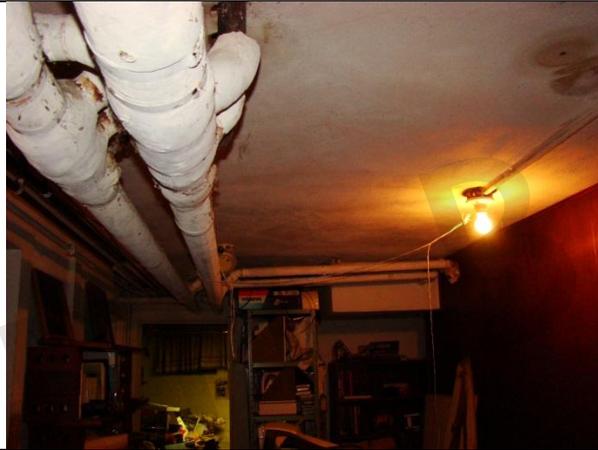
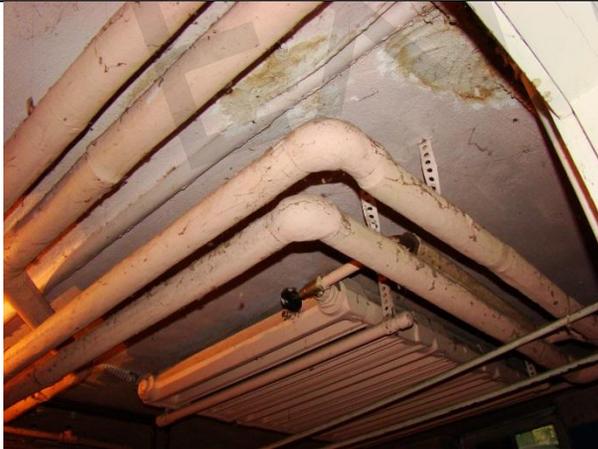
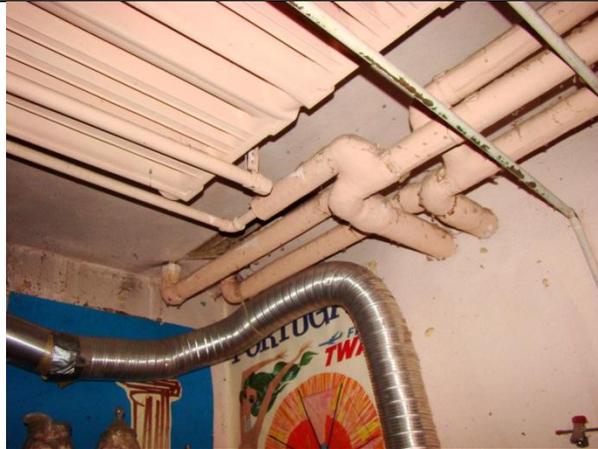
Asbestos pipe insulation in basement
